# Atmel CGA 625 Mounting Evaluation

Saab Space

Estec, May 22nd, 2007

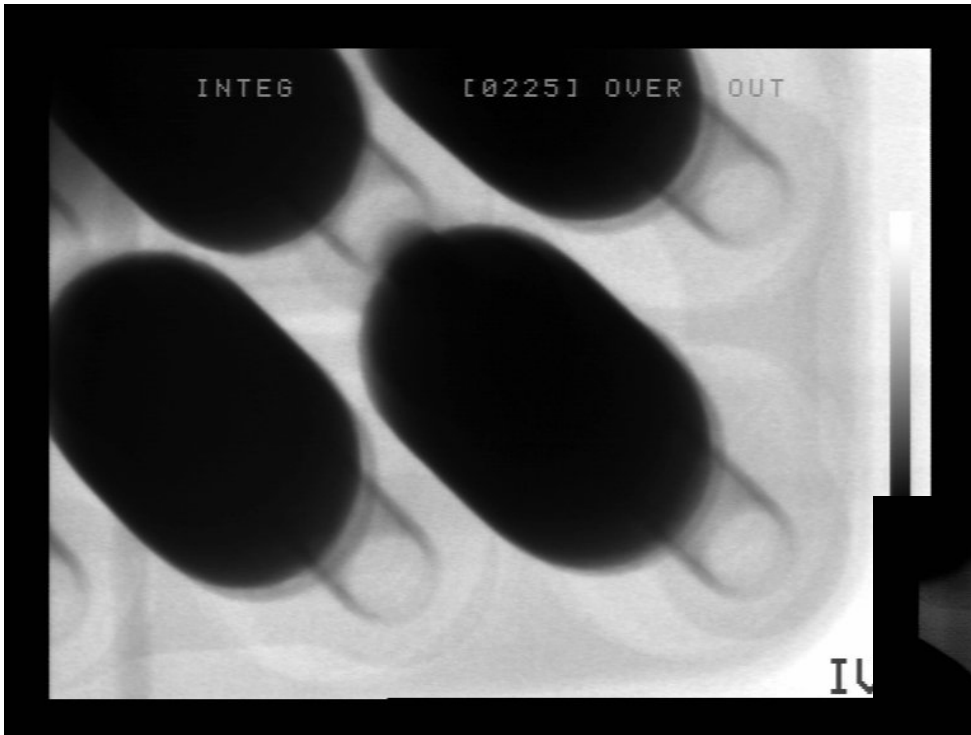
# 3D X-Ray After mounting

Circular pad

Teardrop pad

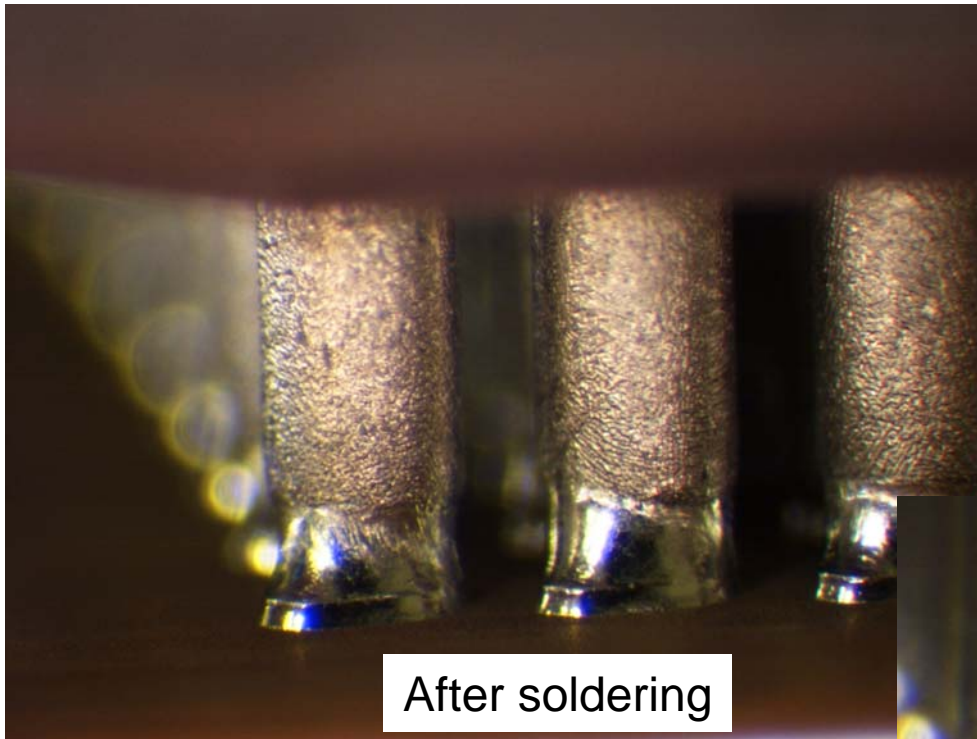
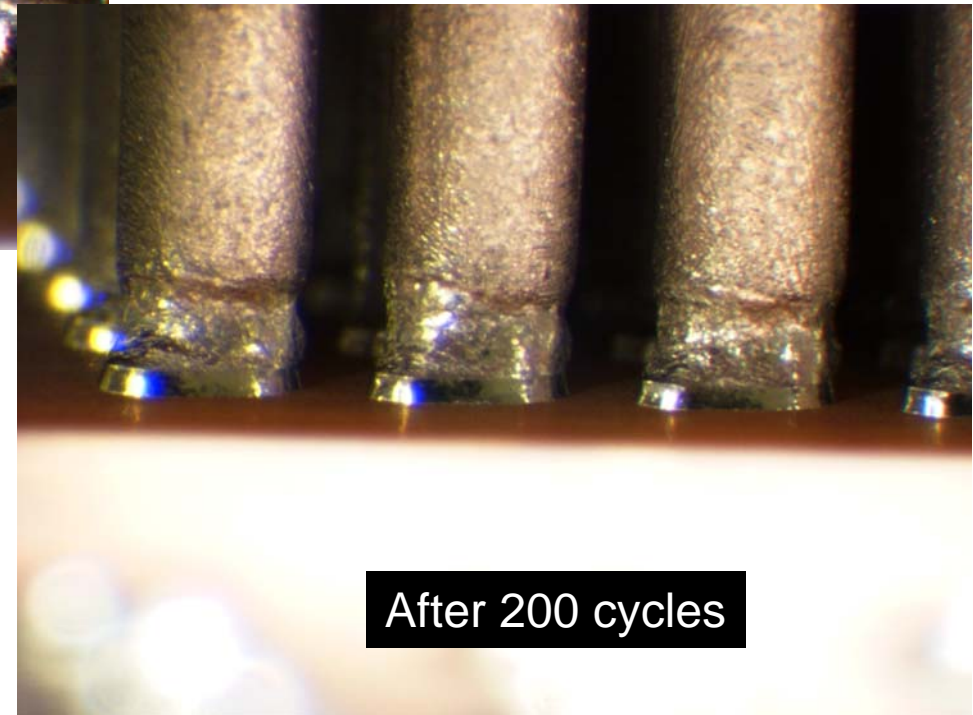
## Visual Inspection - teardrop (1356)

- Electrical: No failures detected
- Visual: No cracks observed in 60x magnifications

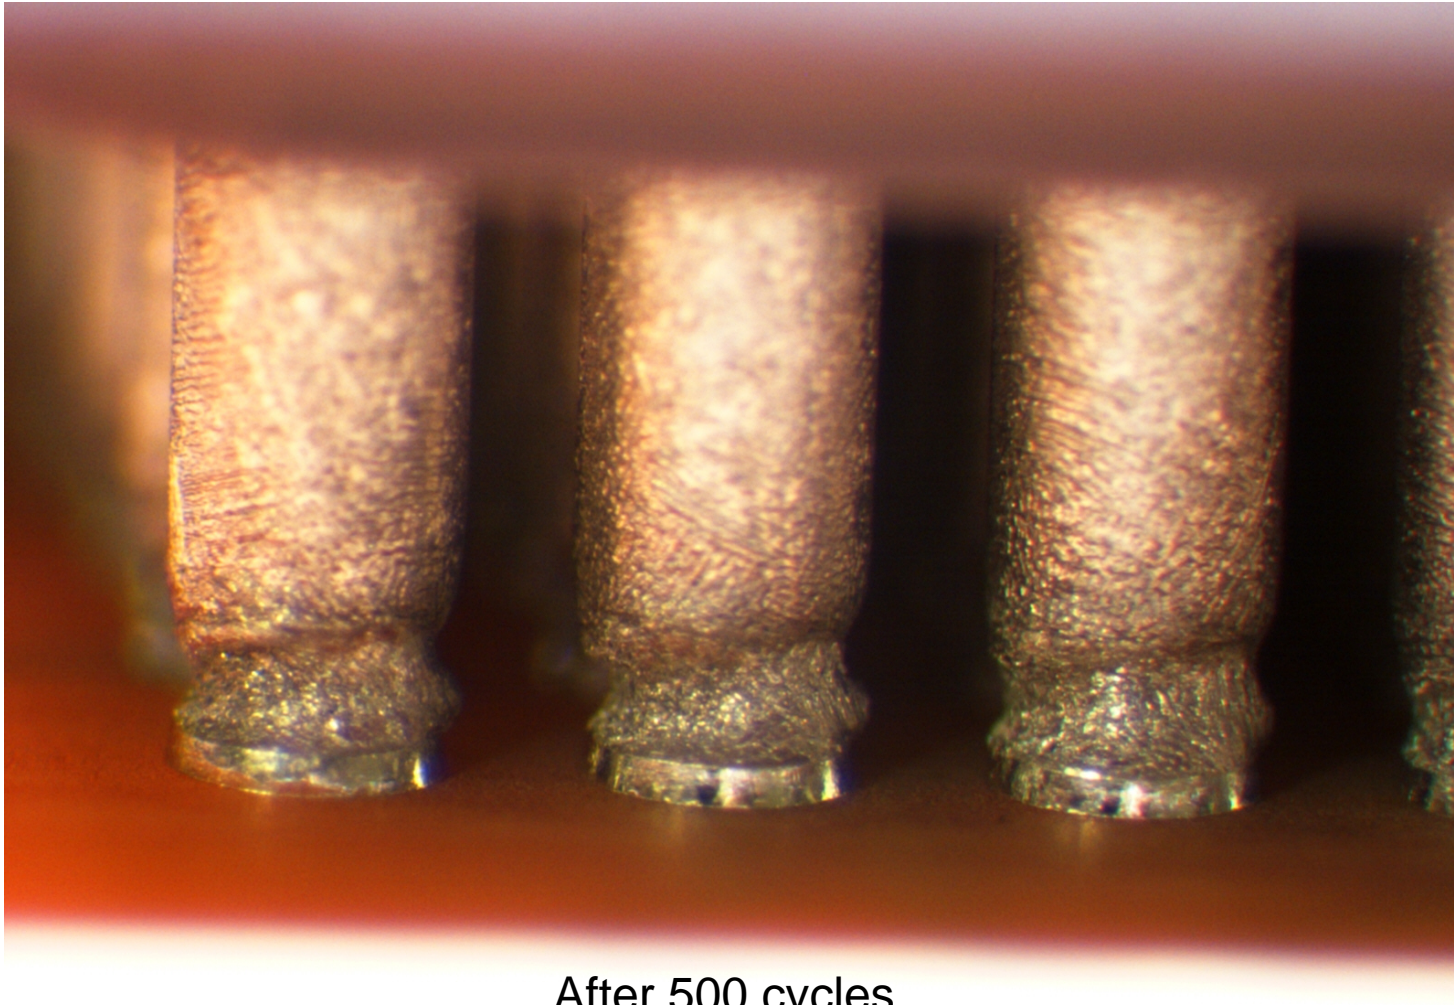
## Visual Inspection – circular pad (1353)

After 500 cycles

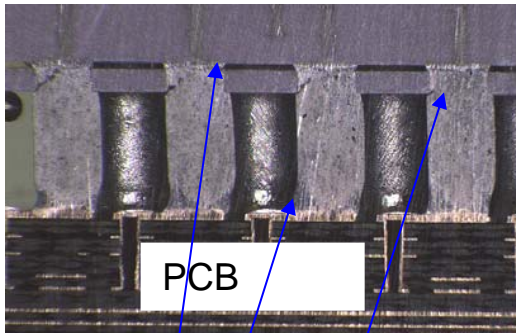
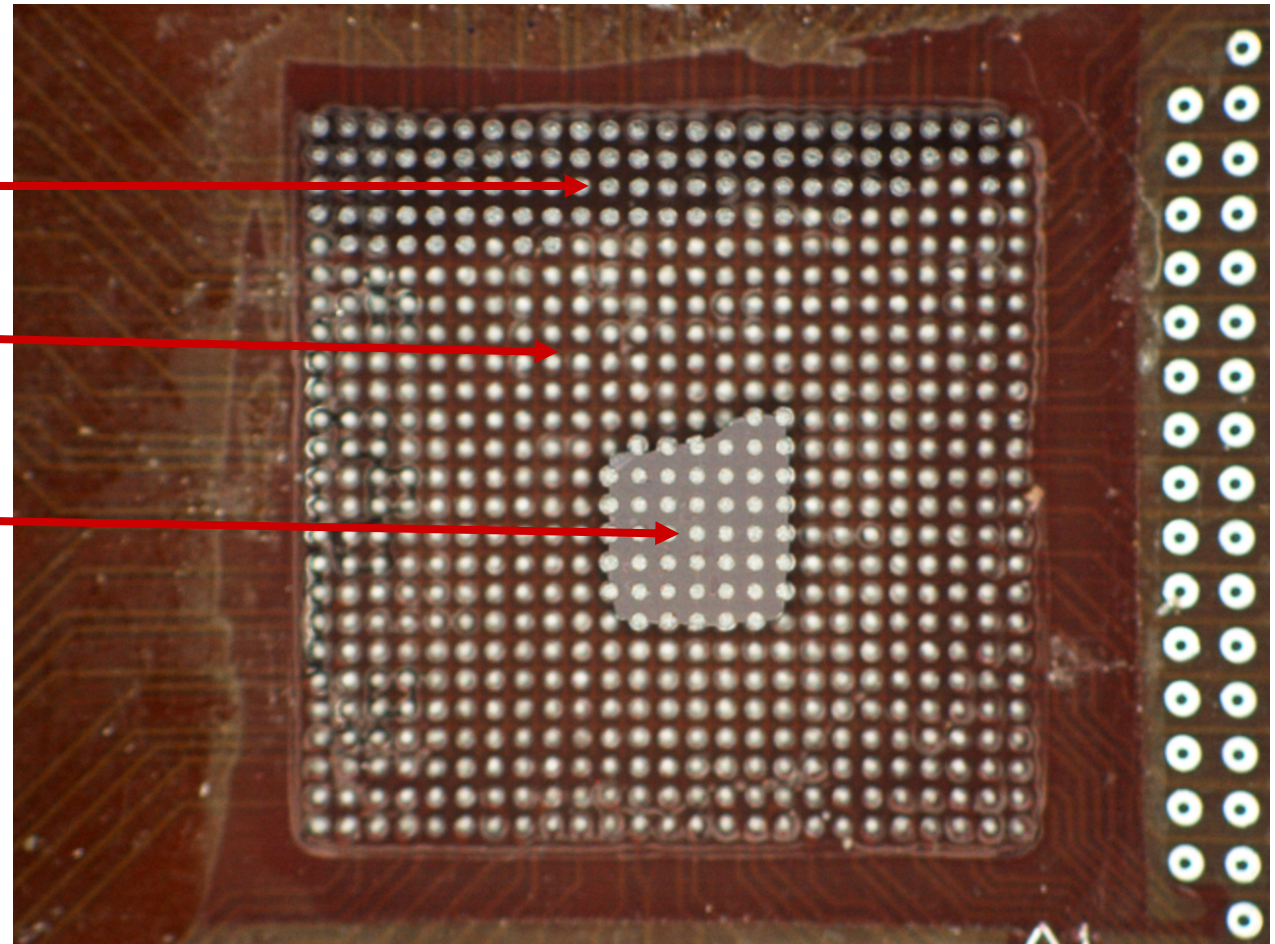
Dye Penetrant (1355)  
Picture of board After 200 cycles

- No cracks > 25% of the circumference of the column observed at PCB-column interface, cracks observed at interposer side

Columns

Break at Pads  
on PCB

Break at  
Package  
pad

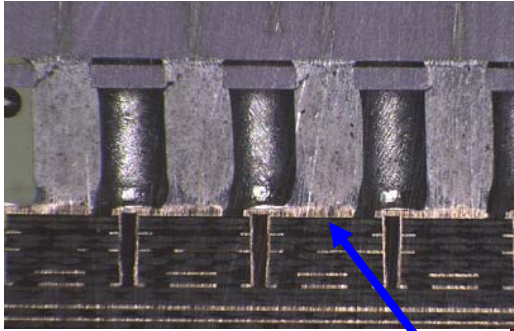
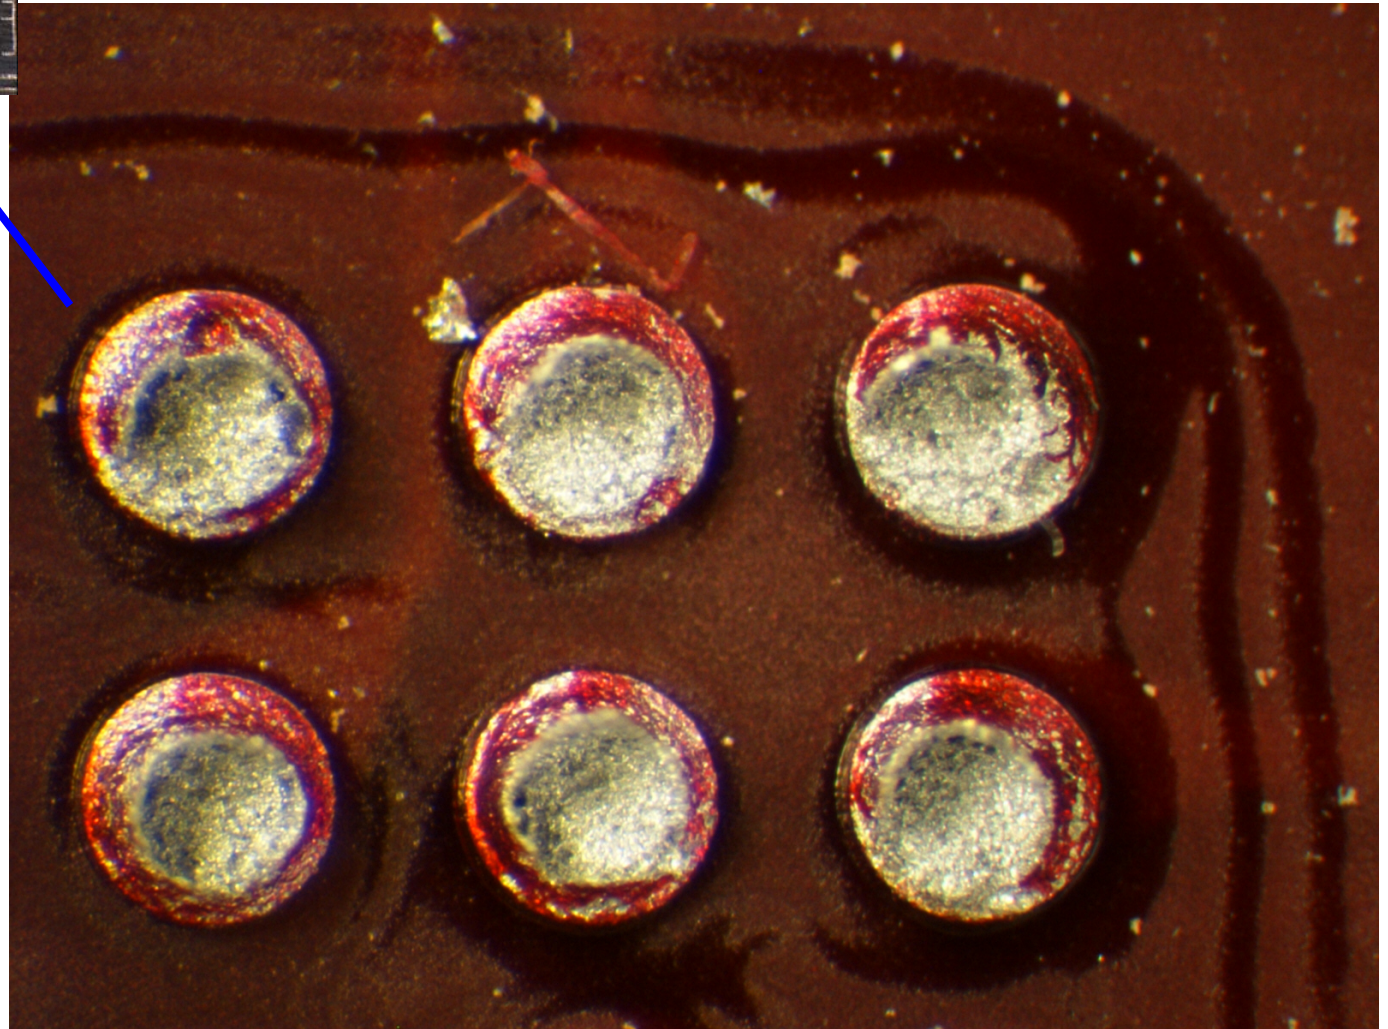
Die Penetrant (1355)  
Board After 200 cycles

Corner Picture  
Solder joint break  
at PCB

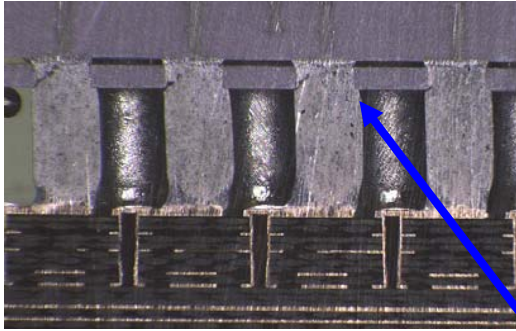
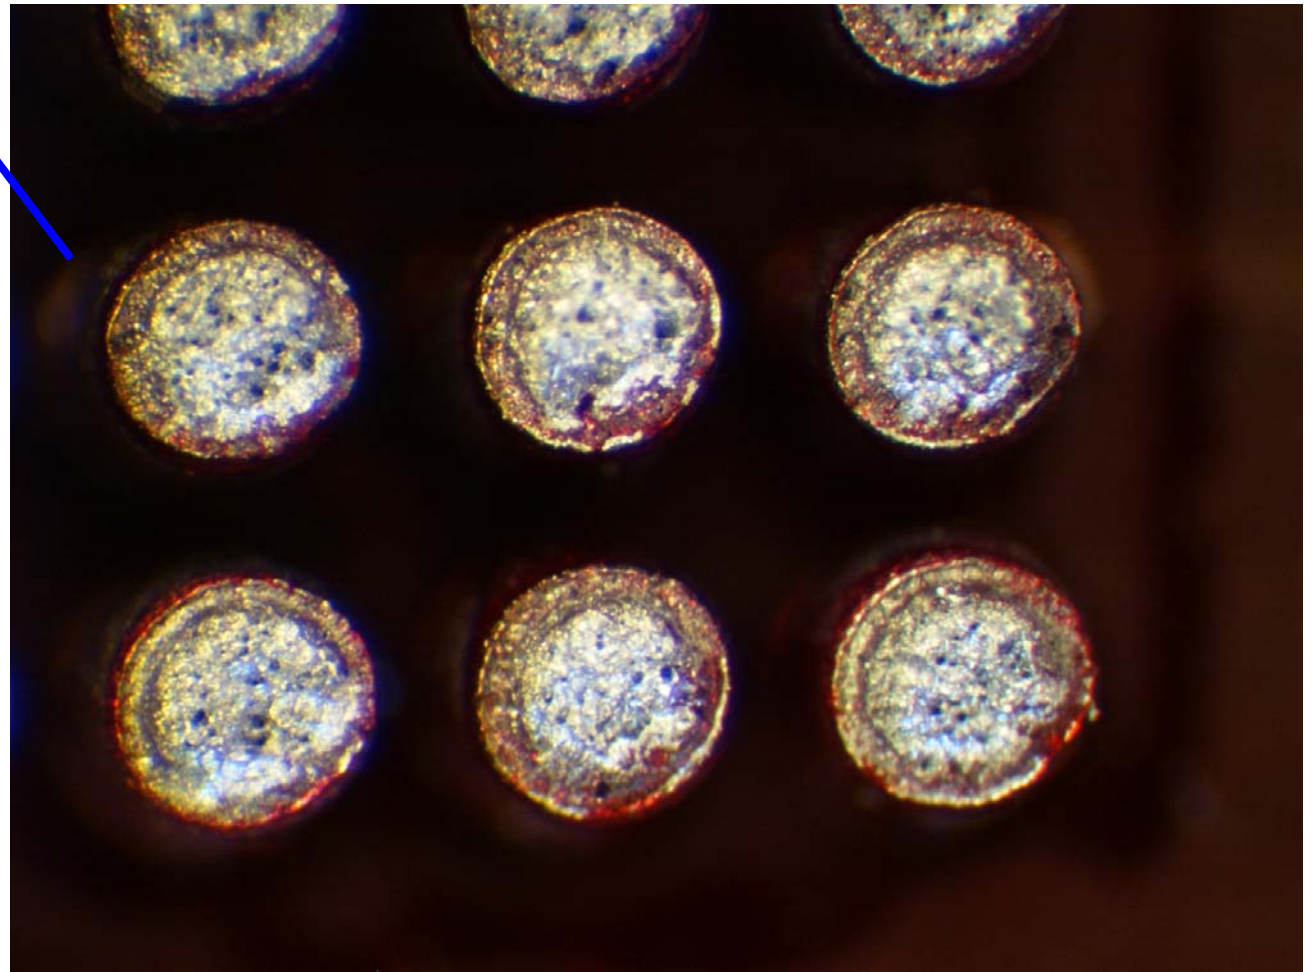
Dye Penetrant (1355)  
Board After 200 cycles

Corner picture  
Solder joint break  
at Interposer

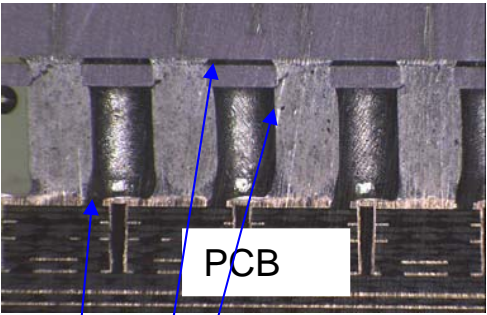
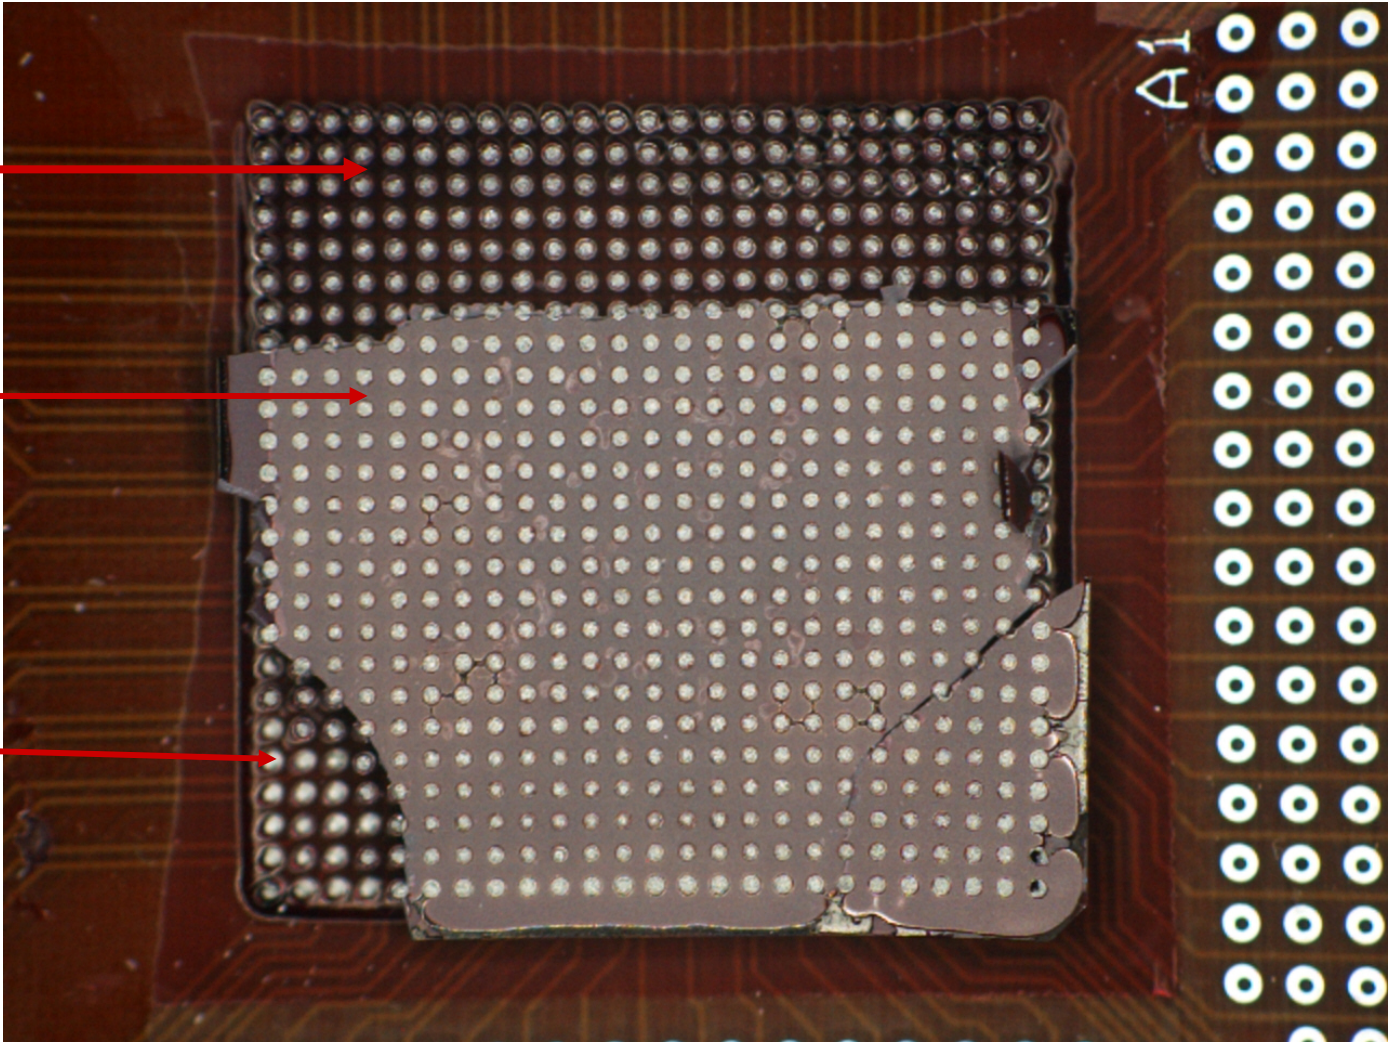
Die Penetrant (1356)  
Picture of board after 500 cycles

Columns

Interposer  
Ceramic

Pads on  
PCB

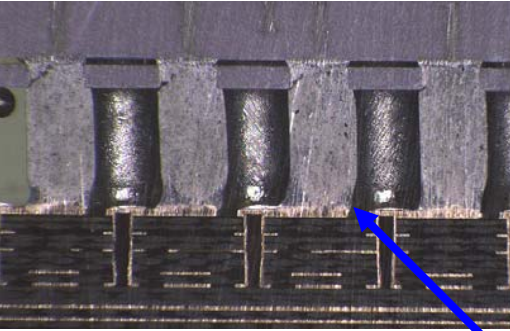
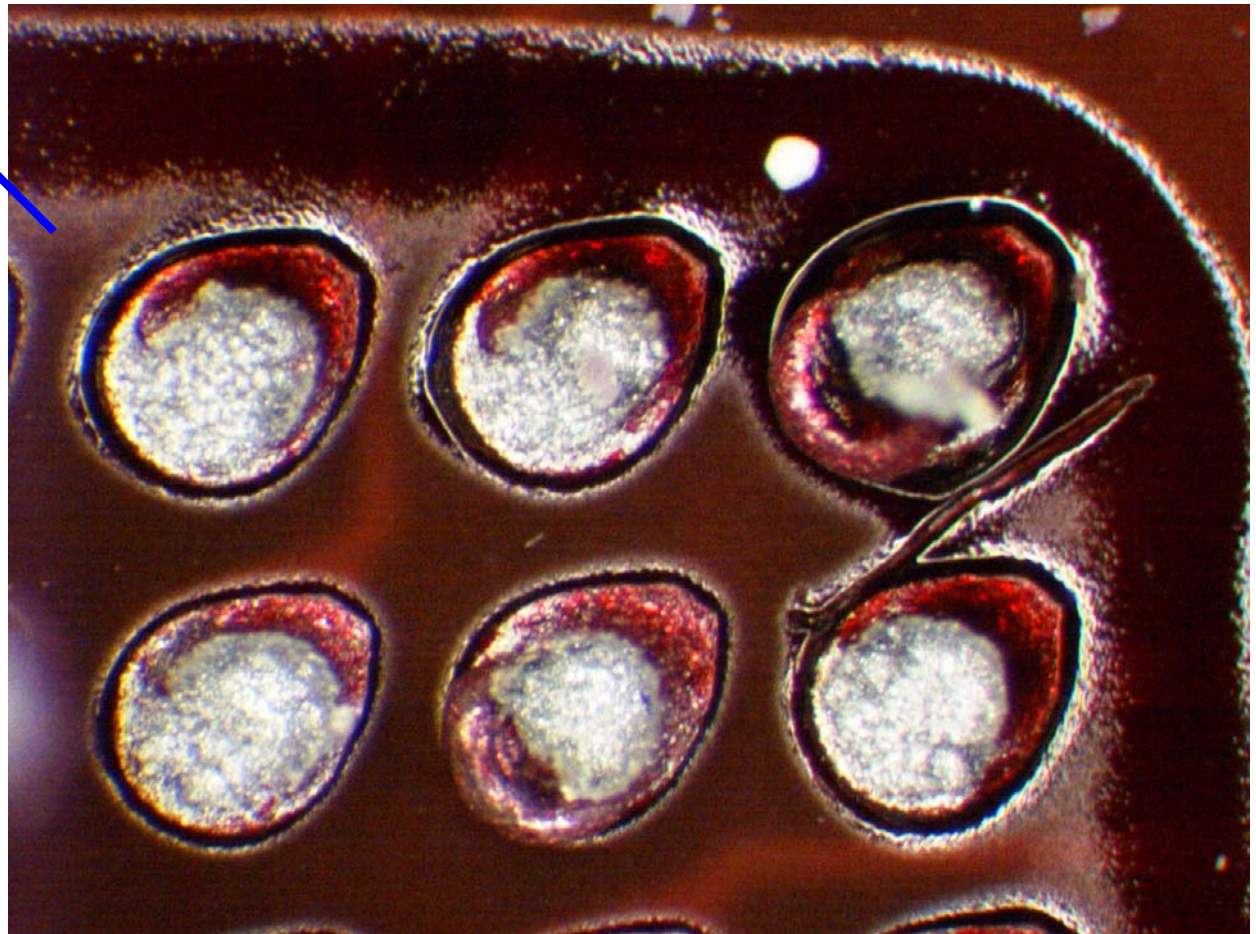
Dye Penetrant (1356)  
Picture of board after 500 cycles

Corner Picture  
Solder joint break  
at PCB

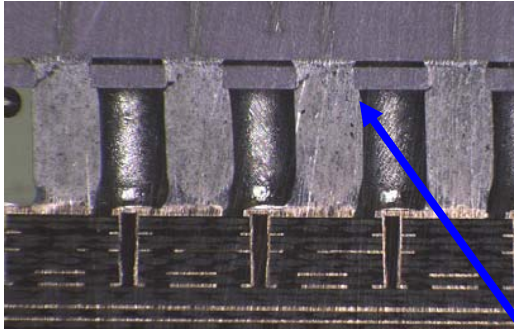
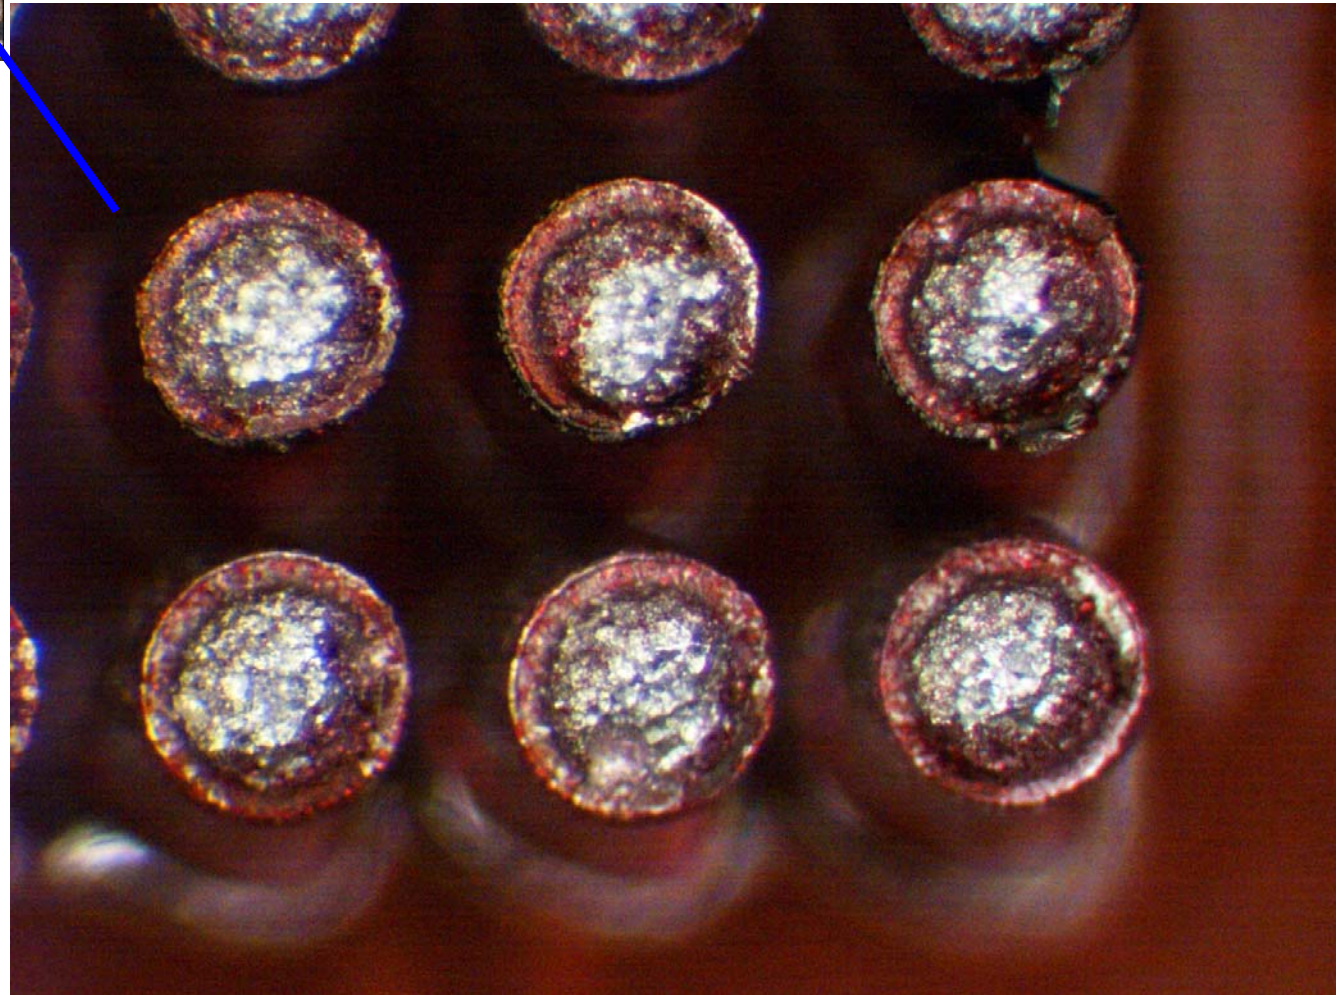
Dye Penetrant (1356)  
Picture of board after 500 cycles

Corner Picture  
Solder joint break  
at Interposer

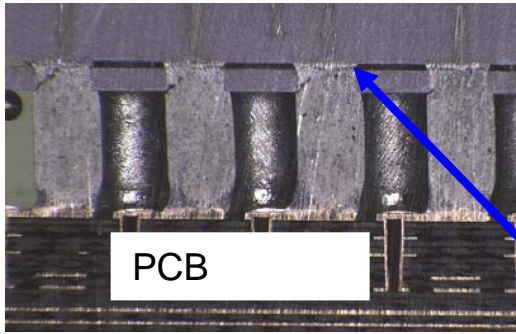
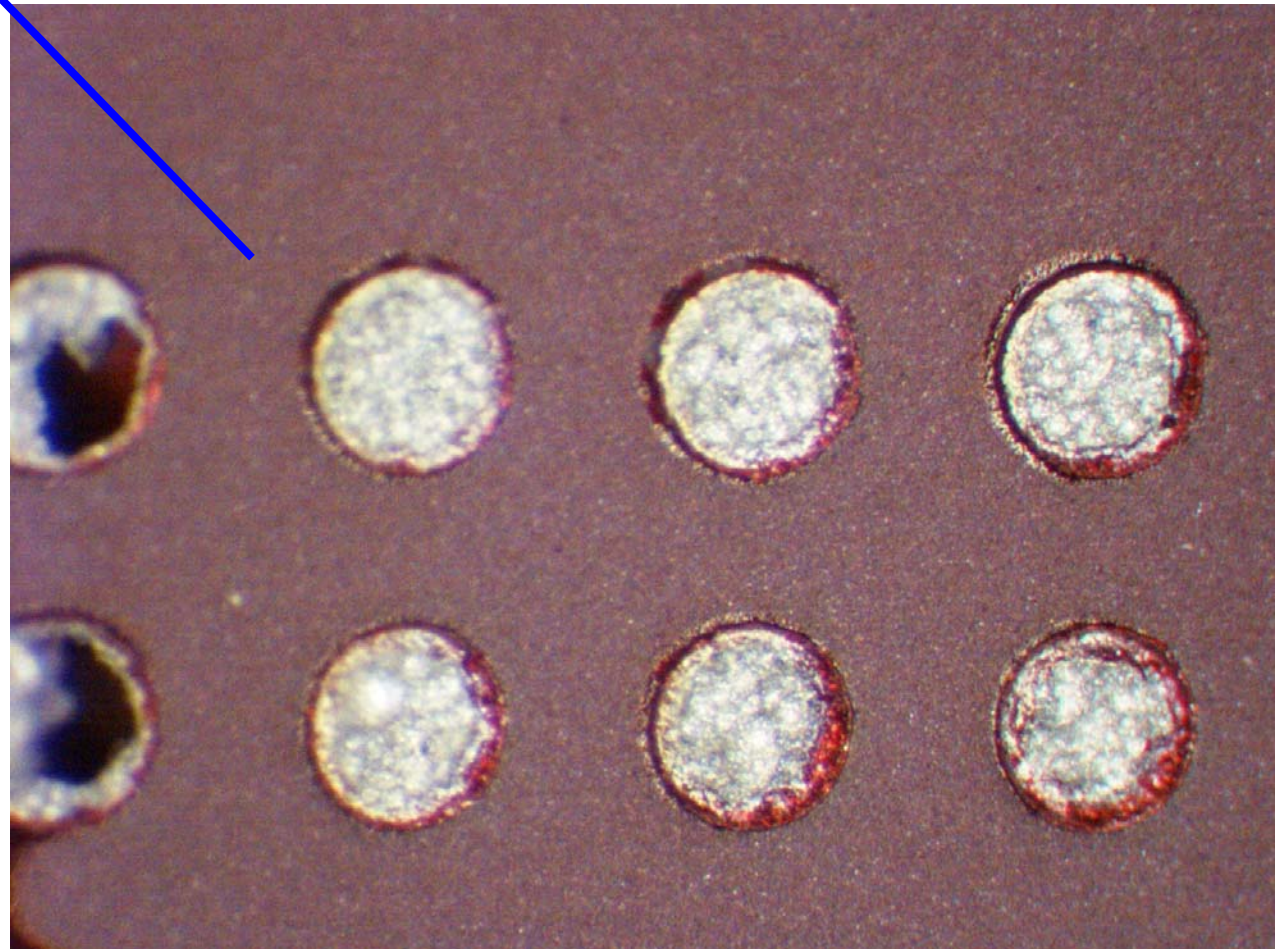
Dye Penetrant (1356)  
Picture of board after 500 cycles

Corner Picture  
Solder joint break  
at package pad

Dye penetrant difficult  
to flow between ceramic  
and package

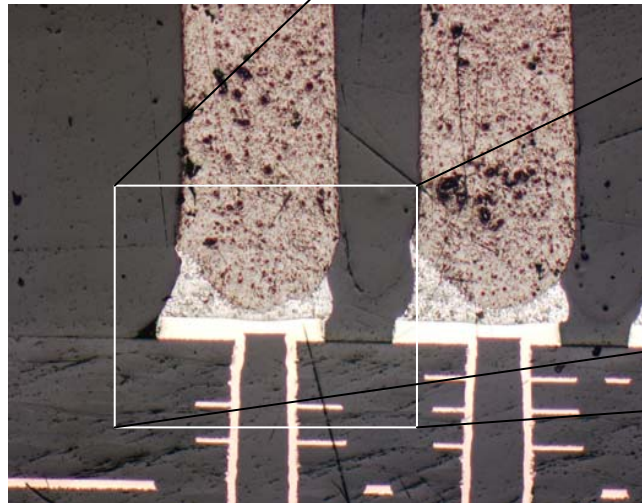
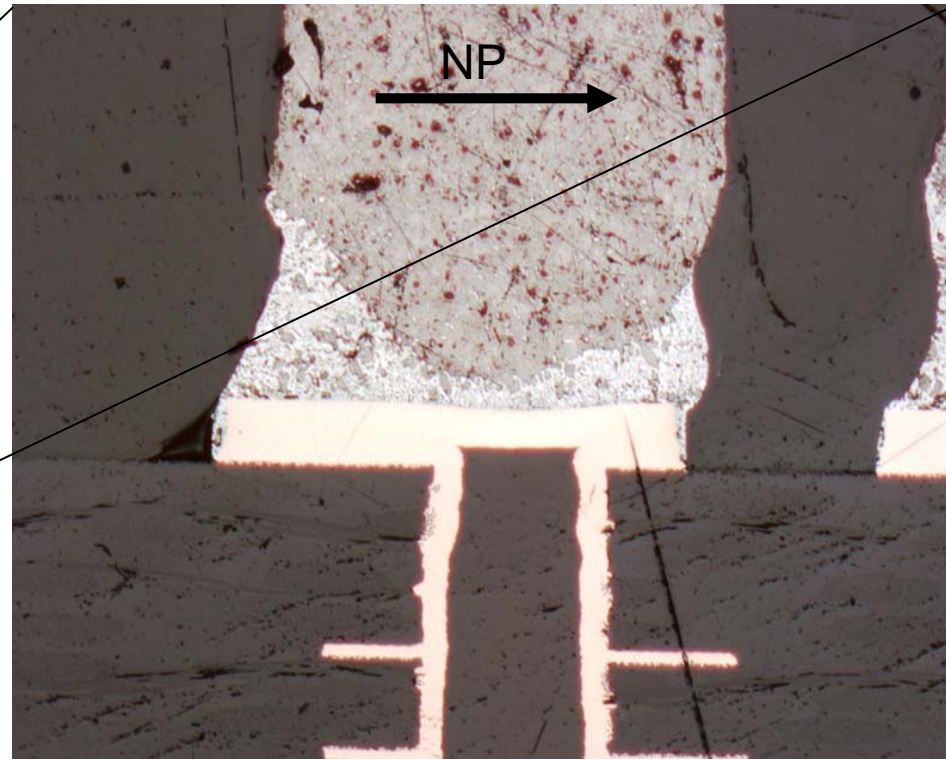
Micro Sectioning (1353)  
Picture of board after 500 cycles

- No cracks > 25% of the circumference of the column observed at PCB-column interface

Solder joints between corner columns and PCB.  
No cracks were found in these solder joints.

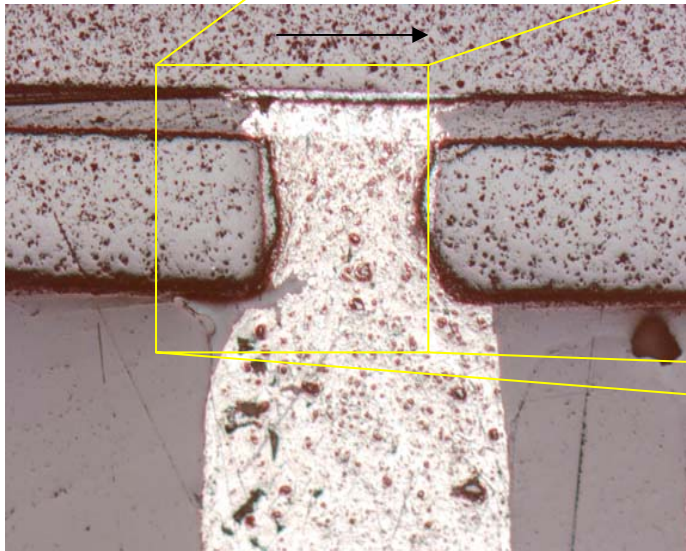
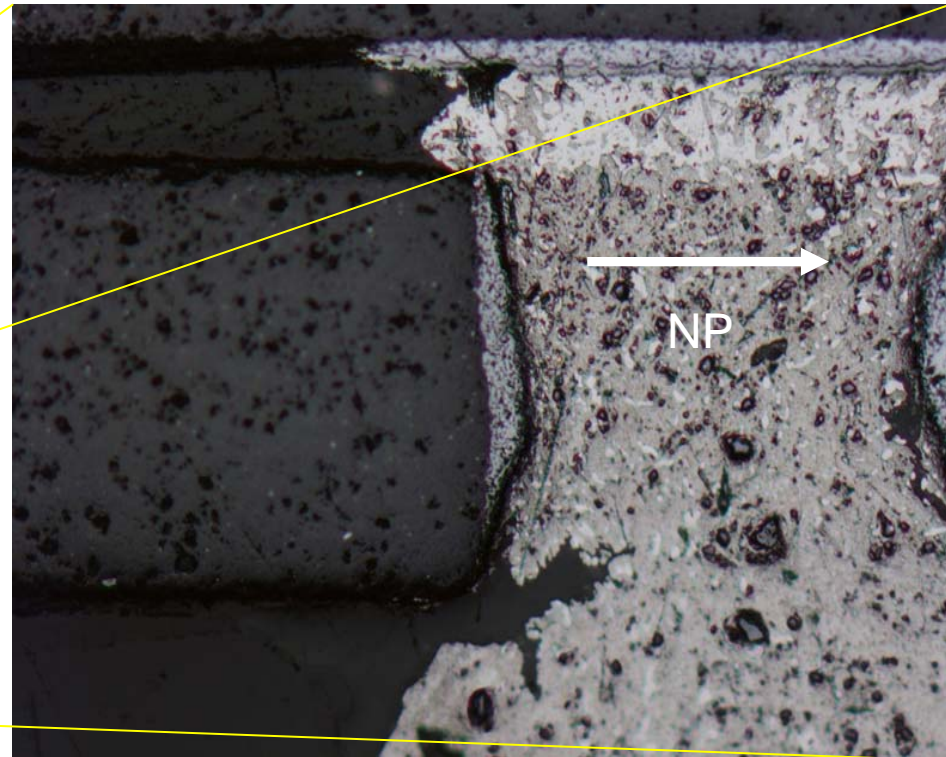
Micro Sectioning (1353)  
Picture of board after 500 cycles

Solder joints between corner columns and package.  
Cracks (typical) were found along the interposer.

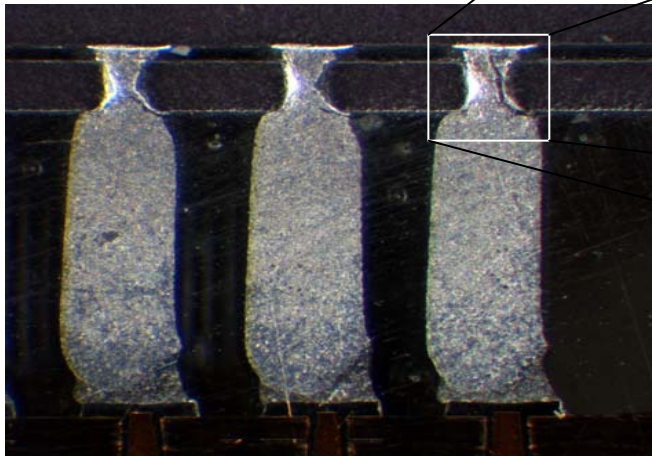
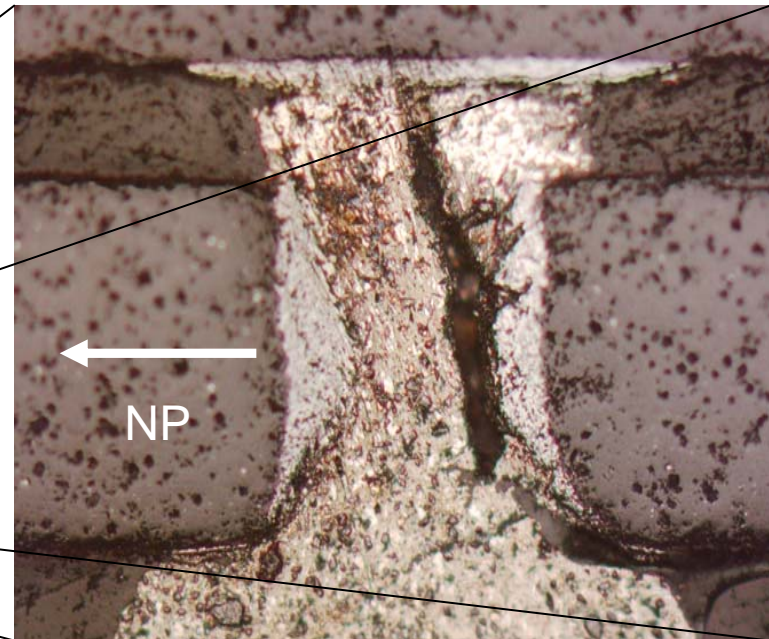
Micro Sectioning (1353)  
Picture of board after 500 cycles

Solder joints between corner columns and package.  
A severe crack were found in the Interposer region.
