COLUMN GRID ARRAY REWORK FOR HIGH RELIABILITY

Atul C. Mehta and Charles C. Bodie Jet Propulsion Laboratories
California Institute of Technology

The details of rework process and results of thermal cycling are presented in this paper.

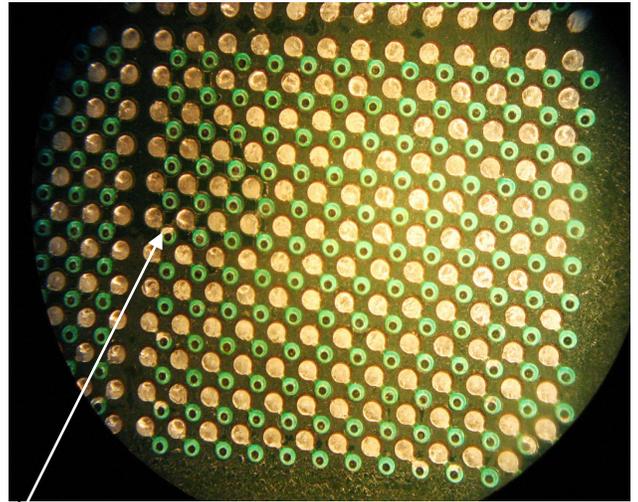
Figure 17 - Conformal Coated Board pads after removal and Clean-up of Columns
Solder mask damage

Removal of the original CGA package from the conformal coated assembly was done using the Hot Gas Rework system. The removal process resulted in all of the columns separating from the ceramic package and remaining soldered to the printed wiring board pads. See Figures 15 and 16. Figure 16 shows columns under UV light reflecting the conformal coat. Each column is attached to the bottom of the ceramic package with Sn63 solder and reflows at the same time as the Sn63 on the pads. The coating adds an adhesive quality to the PWB and, hence, the columns have a greater tendency to stick to the PWB. Removal of the columns and cleaning of the pads of conformal coating residue required 8 full hours of work by a highly skilled technician using solder wick and cleaning solvents. The pad area was very noticeably distressed by the intensive cleaning action. See Figure 15. Further the solder mask between the pad and the associated via was destroyed at three locations. See figure 17. This damage, if not repaired, will result in the solder that is melted during reflow running down the via and, thereby, starving the solder joint between the column and the pad creating a questionable connection. The solder mask was repaired by the application of a tiny ribbon of epoxy isolating the pad from the via preventing the solder from following the trace to the via. From this experience it was recognized that conformal coating of the CGA should be delayed as late in the testing as possible to avoid the necessity of reworking conformal coated packages and to avoid the associated risk to the assembly. The CGA was replaced using the rework system in following sequence.

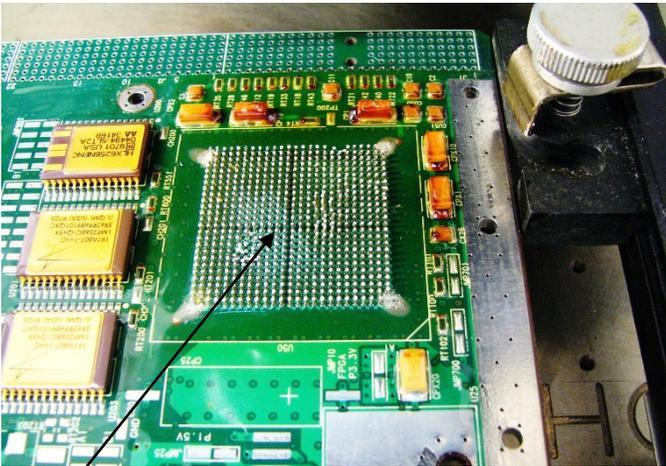
Figure 15 - Most Columns remain on PWB after part removal

Distressed solder mask

- Deposit Sn 63 solder paste on to the pads, using mini stencil.
- Place the device using split vision rework system
- Reflow the solder using the same rework system.

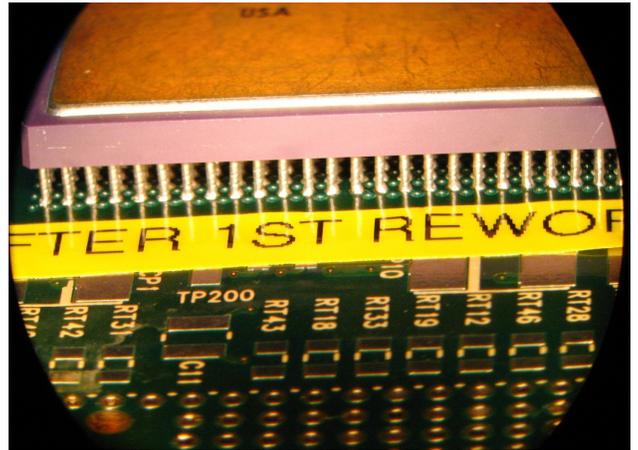
Figure 18 - Solder joint generated by rework process

Figures 18 and 19 shows solder joints formed during the rework process whereas figures 20 and 21 shows the X-Ray views of CGA solder joints. The Joints as viewed in X-Ray image appear to be uniform and without any apparent anomalies.

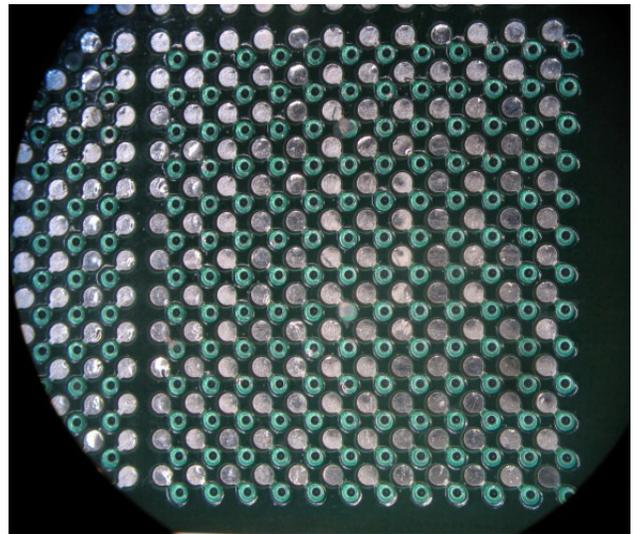
Figure 22 - Non Conformal Coated Board pads after removal of CGA and Clean-up of Columns

Another test sample was prepared and soldered on the vapor phase soldering machine, but was not conformal coated. The CGA was removed using the rework station. The clean-up of the pads took the same technician less than 2 hours to complete. The pad area after rework looked pristine. See Figure 22. There was no damage to the pads or to the solder mask. The new CGA package was placed and soldered using the rework system. The daisy chains were all determined to be 100% connected by the resistance measurements.

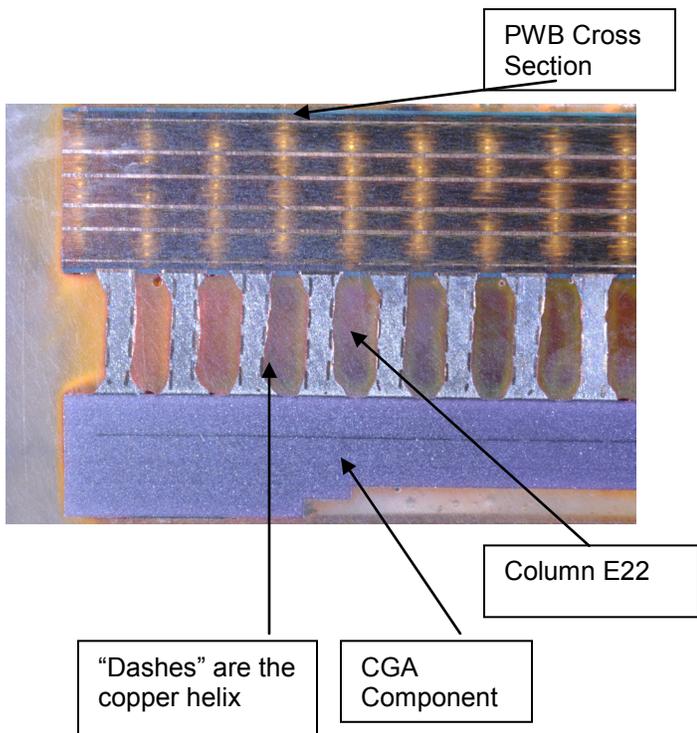
Figure 24 - Suspected Column

A failure of S/N 013-2 was initially detected after 169 Cycles by the continuous monitoring instrumentation. The failure was in chain 1 of the five chains instrumented on each CGA. At 207 cycles manual resistance measurements showed that the circuit had a resistance of 118 ohms. As the measurements were being taken, it was noticed that the resistance of this chain reduced to 9 ohms indicating that the high resistance circuit had sensitivity to movement. (This is consistent with a cracked solder joint). The chain resistance was 2.89 ohms at the beginning of the test sequence which is representative of all chain 1's on all samples.

The test was terminated after 328 cycles with the other chains intact. The measured resistance of the failed string at that time was 64K ohms in contrast to the 3 ohms that is the normal value. Through resistance measurements, the column associated with pin E22 was suspected. Microsectioning was performed by Section 514 Failure Analysis Lab. The photo in Figure 28 labeled "Suspected Column" shows the column E22. The solder fillets appear to be good and are similar to columns adjacent to it. SEM analysis was also performed and no cracks or any anomalies were detected. In fact all solder joints that were inspected were of high quality. The second photo (Figure 29) shows the via associated with the column E22. All vias inspected on the board and on the test coupon provided with the board are intact and are of high quality. No definitive cause of the failure was found, but all evidence would lead one to believe that the solder process was not at fault. The early failure (169 cycles), when all other boards went through many more cycles with no failures, indicates an infant mortality of the part.
