# Atmel CGA 625 Mounting Evaluation

Saab Space

Estec, May 22nd, 2007

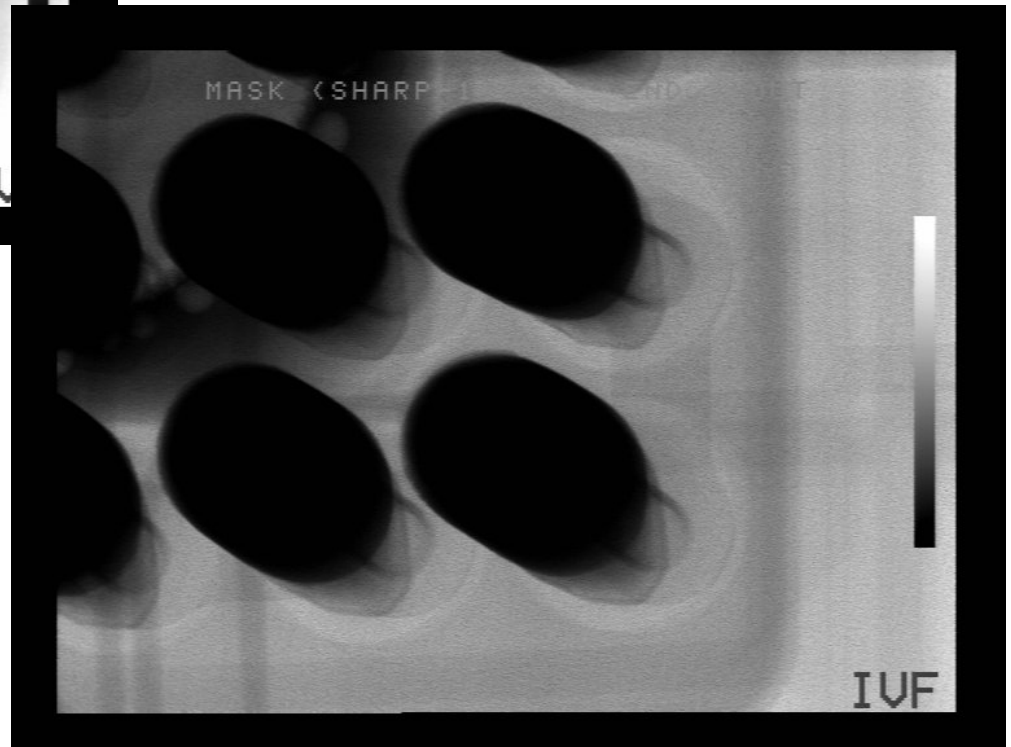
Circular pad

Teardrop pad

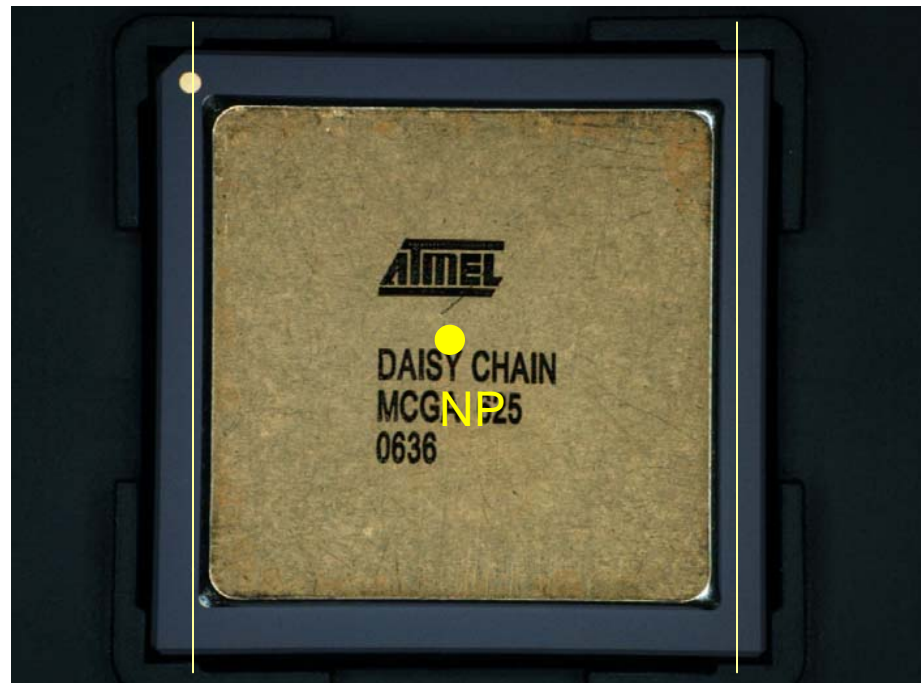
Cross sections for the micrographs

- No cracks > 25% of the circumference of the column observed at PCB-column interface
