COLUMN GRID ARRAY REWORK FOR HIGH RELIABILITY

Atul C. Mehta and Charles C. Bodie Jet Propulsion Laboratories
California Institute of Technology

The details of rework process and results of thermal cycling are presented in this paper.

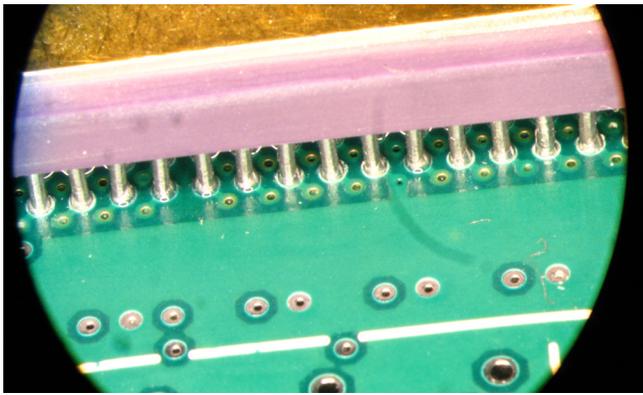
Figure 12 - CGA Columns Soldered to PWB

Figures 12 and 13 Shows a series of typical solder joints obtained after the vapor phase reflow.

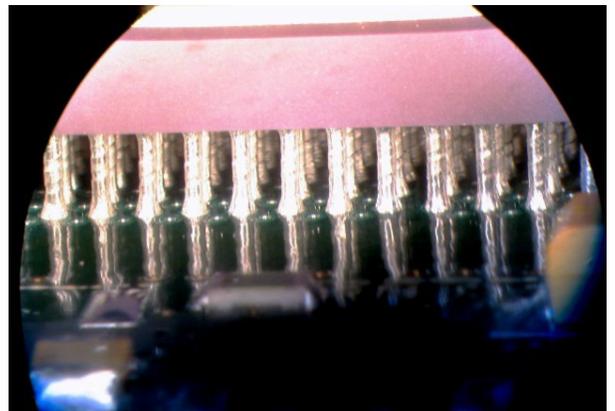
Figure 23

In Figure 23, shown are the Close up view of Solder joints generated by rework process.
