Reliability of CGA/LGA/HDI Package Board/Assembly

JPL Publication 12-3 2/13

NASA Electronic Parts and Packaging (NEPP) Program
Office of Safety and Mission Assurance

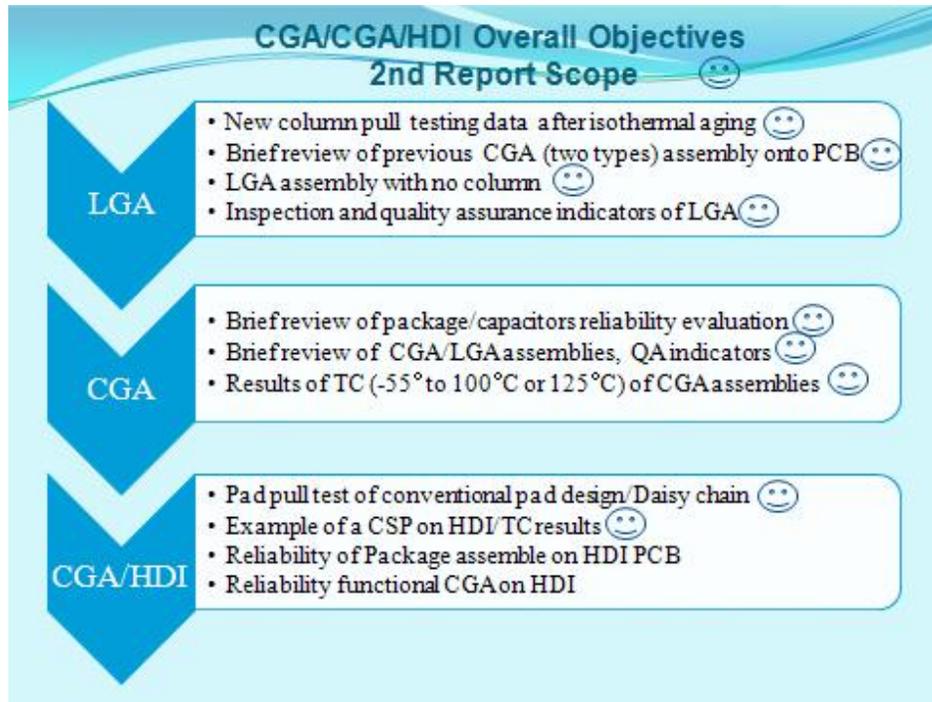
Figure 1. Test matrix for CGA/CCGA/HDI package/board/assembly program with identification of the key areas of investigation.

The overall objectives and approaches of the reliability evaluation of CGA/LGA/HDI package/board/assembly are summarized in Figure 1. Topics marked with smiley faces are investigated and either presented previously [1] or will be covered in this or follow-on reports when sufficient data become available. The overall goal is to develop qualification guidelines for advanced high input/output (I/O) column/land grid array (CGA/LGA) assembled onto both conventional and high density interconnect (HDI) printed circuit/wiring boards (PCB/PWB). This report will briefly address results for package evaluation and assembly optimization as well as detail results of thermal cycle testing and failure analyses.

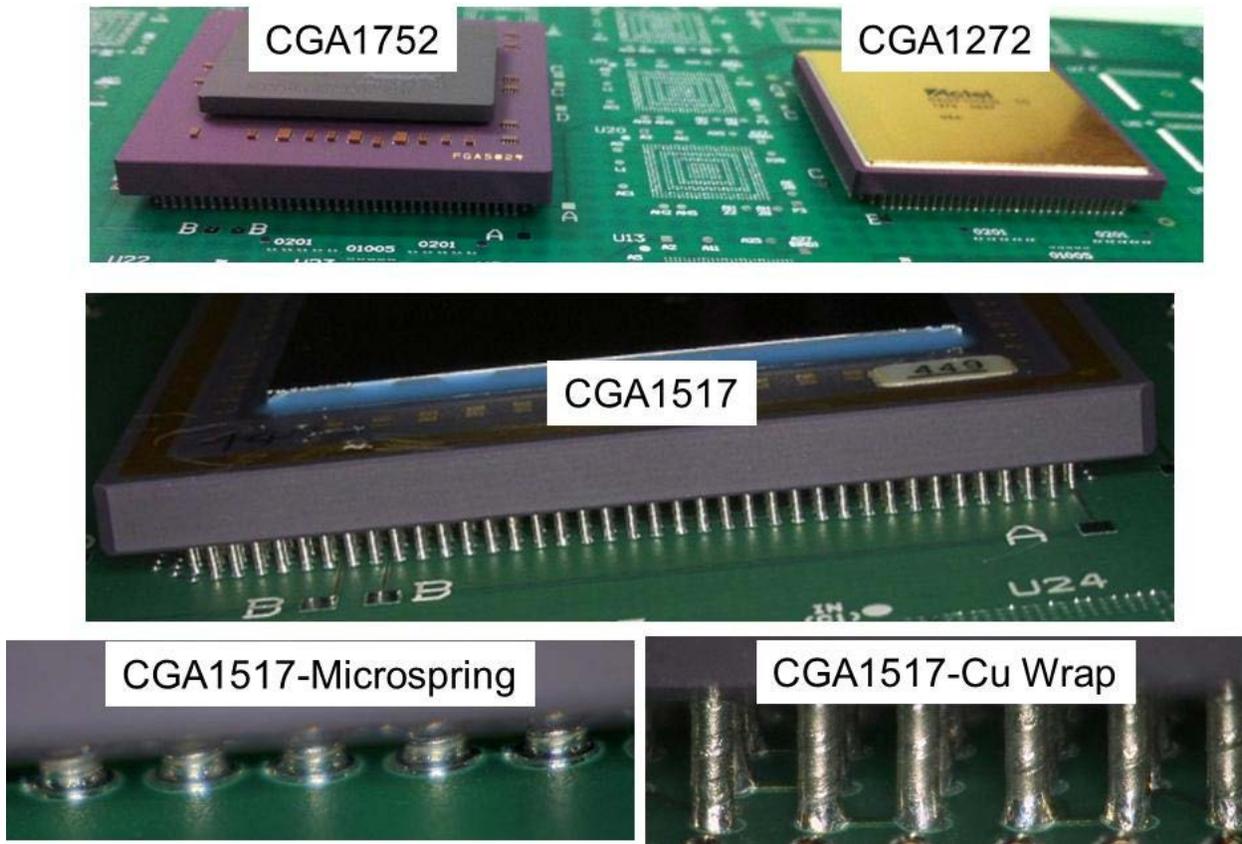
Figure 2. Four CGA types: CGA1752 with pure solder column (top-left) and CGA1272 with copper-wrapped solder column (top-right), CGA1517 with microspring column (bottom-right), CGA1517 with Cu Wrapped column (bottom-left).

Two CGA packages with 1752 and 1272 I/Os and two column styles were evaluated, one with a pure solder column and the other with a copper-wrapped solder column. The scope of evaluation also included a ceramic array package with 1517 I/Os that came as land grid array (LGA) with no column attachment. LGAs were converted into CGA by performing two styles of column attachment at two facilities. One style had copper wrapped onto a solder column with a diameter slightly lower than standard value; the other style had a microspring coil with no solder column, but a standard diameter. Figure 2 shows photomicrographs of four CGA packages and their column configurations. Integrity of the Cu-wrapped column was established with isothermal aging at 125°C for up to 1000 hours of aging.

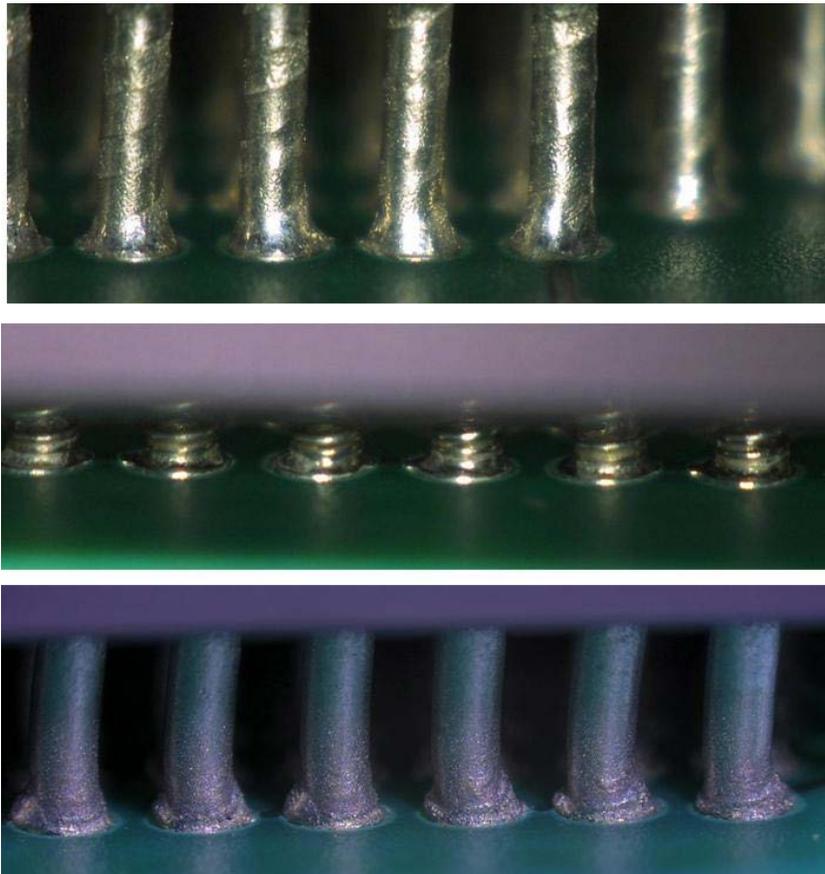
Figure 3. Representative photomicrographs of three solder columns solder joint quality after 200 thermal cycles ($-55^{\circ}/125^{\circ}\text{C}$) for CGA package assemblies.

Four CGA packages (CGA1272, CGA1509, CGA1517, CGA1752) with three column types (pure solder, copper-wrapped, and microspring columns) were assembled onto conventional printed circuit boards using three types of tin-lead solder paste alloys. The inspection results of the peripheral columns after assembly revealed that the quality of solder joints to be acceptable (see Figure 3). X-ray photomicrographs, showing the quality of solder joint assemblies and applicable workmanship defects, revealed no shorts or significant solder balling. Four types CGA assemblies were subjected to thermal cycling for evaluation of solder joints as well as capacitor and internal flip-chip die on package. Assemblies were subjected to two extreme profiles representative of use for high reliability applications. The thermal cycles ranged from a low temperature of -55°C to maximum temperatures of either 100°C or 125°C with slow ramp-up rate of $3^{\circ}\text{C}/\text{min}$ and dwell times of about 15 minutes at the two extremes. Optical, SEM, and X-ray inspection of assemblies were performed prior to thermal cycling to evaluate solder joint quality and workmanship defects and subsequent inspections during thermal cycling exposures established solder damage and progress with cycling. Photomicrographs illustrate key inspection findings after up to 200 thermal cycles are presented. Figure 3 provides examples of such

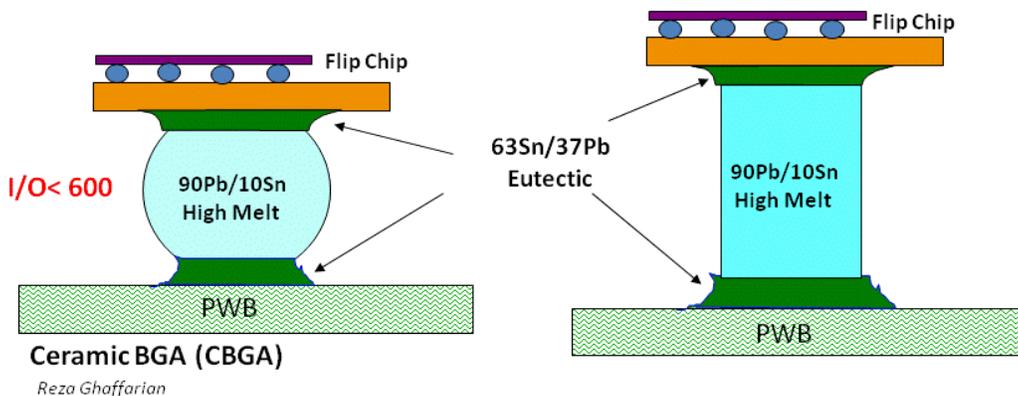
Figure 4. Examples of ceramic column grid array (CCGA or CGA) and ceramic ball grid array (CBGA) package configurations.

CGA packages are preferred to CBGA (see Figure 4) since they show better thermal solder joint reliability than their CBGA counterparts. For most high reliability applications, CGAs show acceptable solder joint reliability for larger packages and higher than 300 I/Os (when resistance to thermal cycling is significantly reduced for CBGAs with increasing package size and I/Os). To limit the growth of package size, most ceramic packages with more than about 1,000 I/Os come in the CGA style with 1-mm pitch or lower.

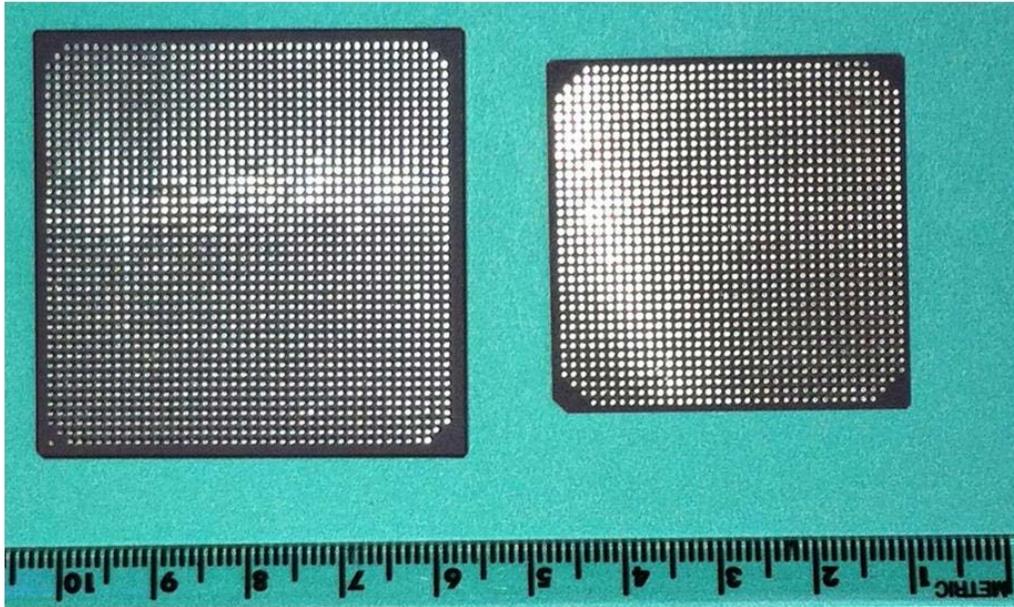
Figure 5. The two column grid array (CGA) packages; 1752 I/Os (left) and 1272 I/Os (right). Note that in both cases corner columns are removed by the manufacturer.

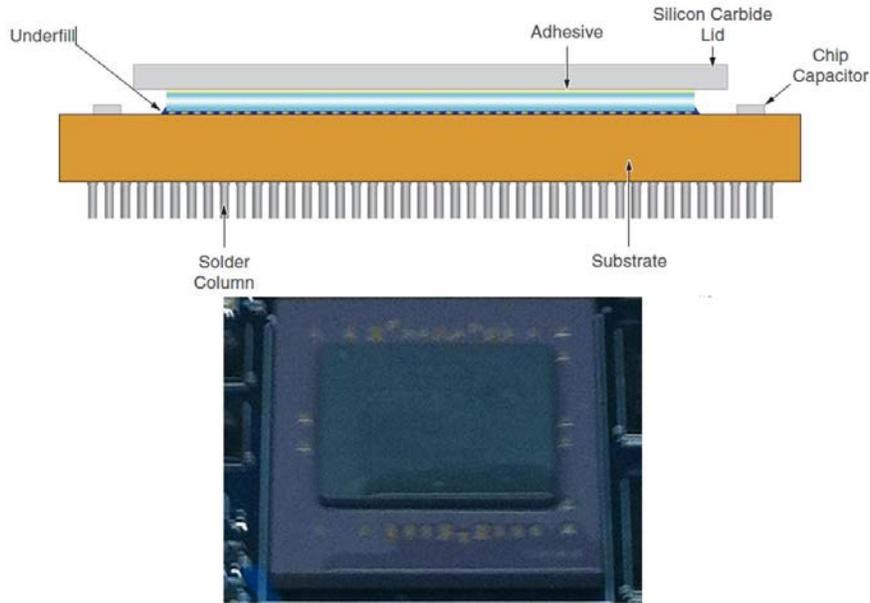
Figure 6. Construction of CGA 1752 I/O package (top) and photo of package showing the exposed chip capacitors.

The two CGA package types were inspected by microscope to detect any workmanship defect anomalies, such as bent columns, and to verify the quality and uniformity of solder joints for column attachments. (see Figure 6, for representative photomicrographs of the two packages.) The 1752 package has pure tin-lead solid solder with high lead concentration (90Pb/10Sn); the 1272 CGA package has slightly lower lead solder content (80Pb/20Sn), but solder columns are wrapped with copper helical spring. Copper-wrapped columns are also tin-lead coated and therefore do not have the appearance of copper except for the exposed flat area on top.

The CGA1272 is hermetically sealed with no additional chip capacitor parts. The CGA1752 is non-hermetic, has an additional chip capacitor on top of the ceramic substrate, and is exposed. Figure 6 shows a generic construction of this package provided by the manufacturer along with a photo of the package from the top. Inspection of chip capacitor solder joints for a package received in December 2010 revealed a number of unacceptable solder joints, based on NASA workmanship standards. For this reason, the solder joints for these chip capacitors were further characterized by SEM and subjected to a limited number of thermal shock cycles. The results of inspection and environmental evaluation are discussed in the following sections.

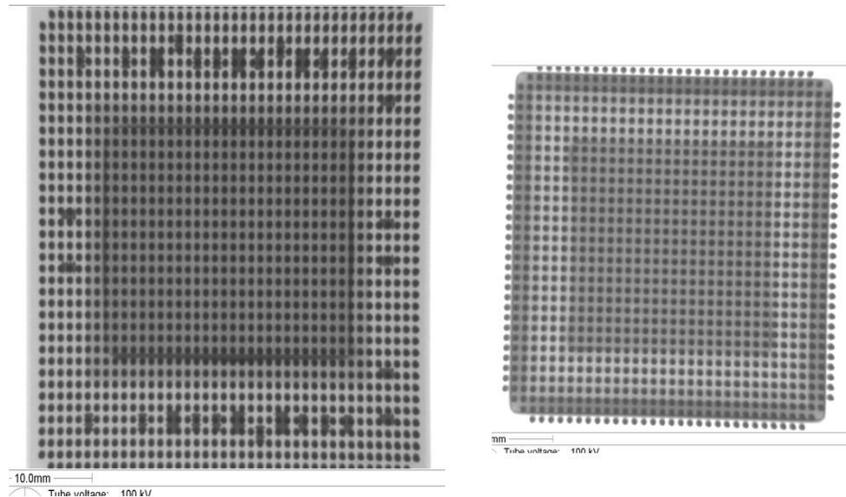
Figure 7. X-ray photomicrographs of CGA 1752 I/Os (left) and CGA 1272 I/Os (right); the darker areas are where chip capacitors are located.

A real-time 2D X-ray system was used to determine the integrity of column solder joint attachment, among other features of these packages. Figure 7 shows representative X-ray photomicrographs of CGA1752 and CGA1272.

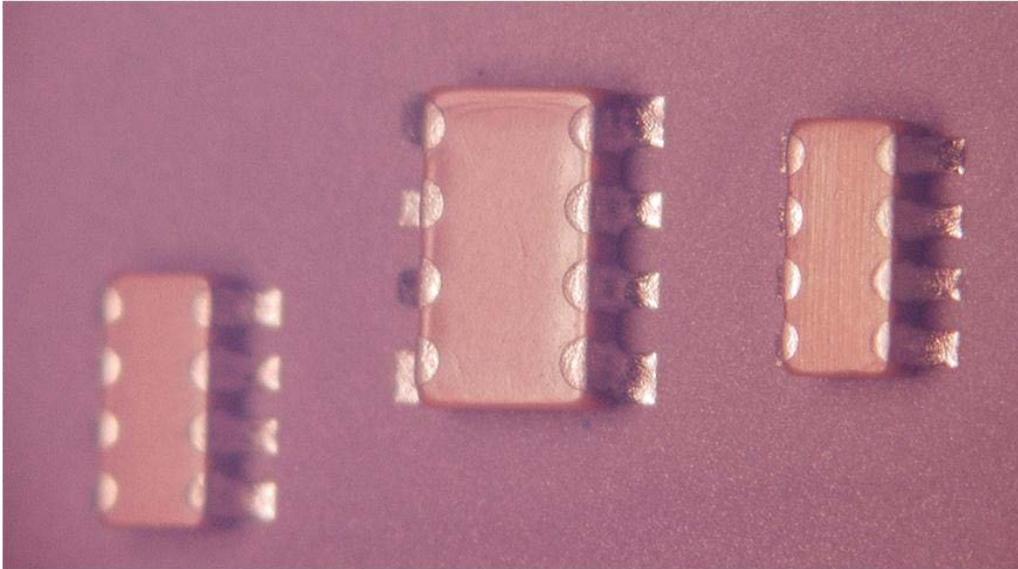
Figure 8. Chip capacitors showing better solder joint quality in the May 2011 set.

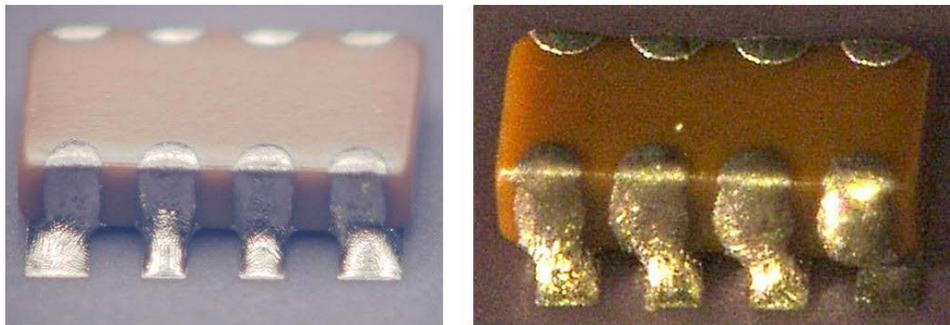
Figure 9. Chip capacitors showing inconsistency in solder joint quality; the far right solder is clearly unacceptable.

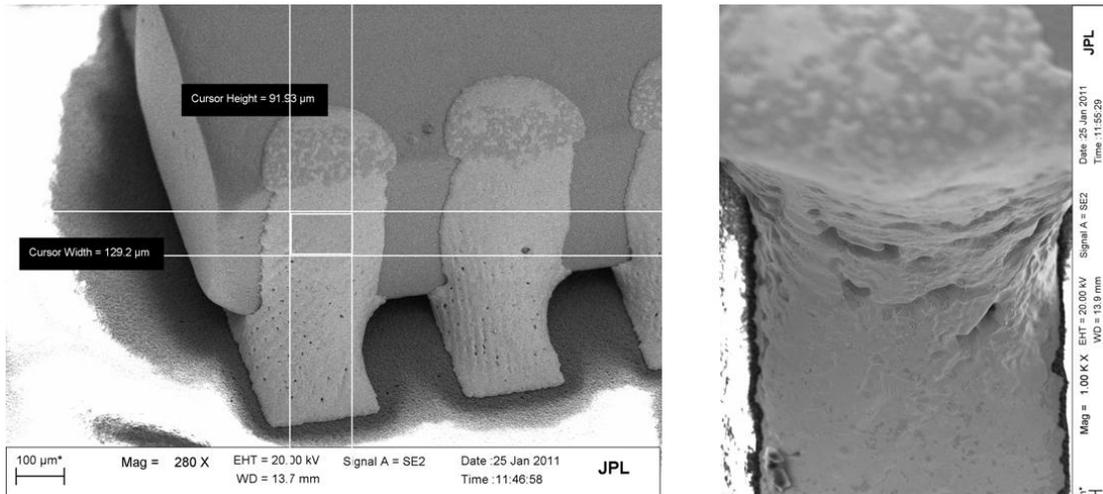
Figure 10. SEM photomicrographs showing the nature of solder joints at much higher magnification.

Further characterizations were performed using SEM to better define microstructure. Figure 10 shows a representative example of solder joint quality at a higher magnification. In addition, elemental analysis was performed using dispersive X-ray spectroscopy (EDX/EDS) to obtain semi-quantitative elemental results for the solder joints. The results showed that indeed they are high lead tin-lead solder (90Pb/10Sn), similar to the column solder alloy. The melting point of these solder alloys is higher than the tin-lead commonly used to attach columns onto PCB. High lead solders generally show a lack of shininess and

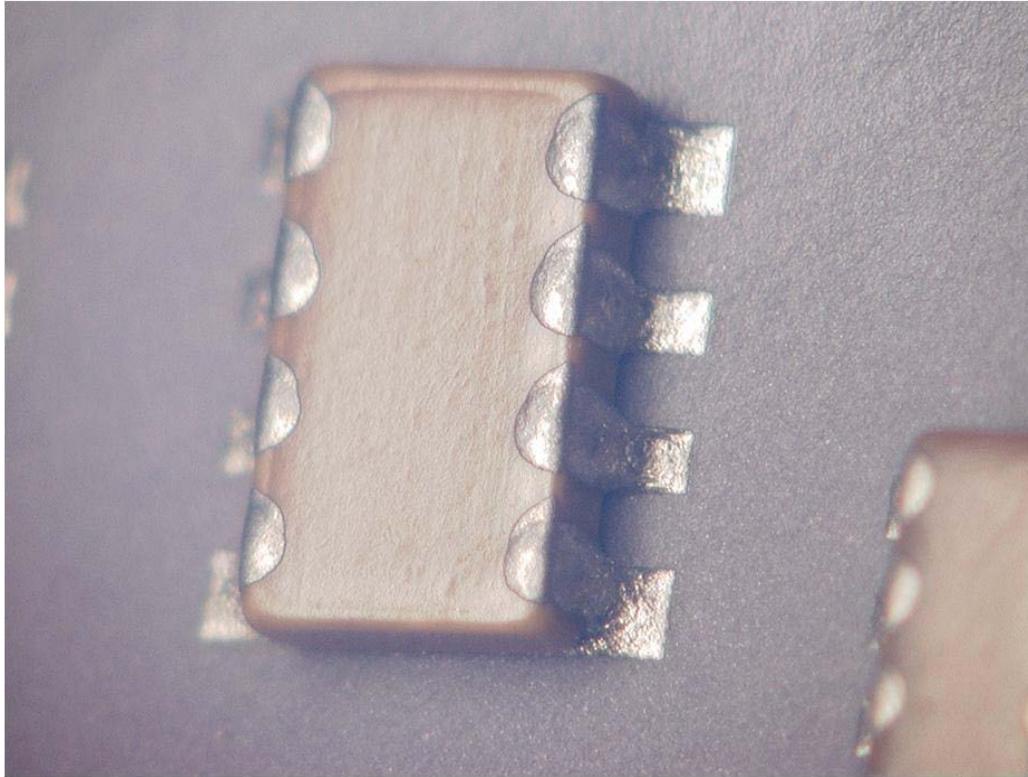
Figure 11. Chip-capacitor solder joint quality after 200 thermal shocks (-55° to 130°C) showing no signs of cracks.

Figure 11 shows representative solder joints after 200 thermal shock cycles. No evidence of significant damage or crack initiation was observed. Resistance of solder joint to thermal shock is attributed to good coefficient of thermal expansion (CTE) match of ceramic chip capacitors to ceramic CGA substrate. The higher melting temperature of high lead (tin-lead alloy) solder also contributed to its high resistance to thermal shock cycle.

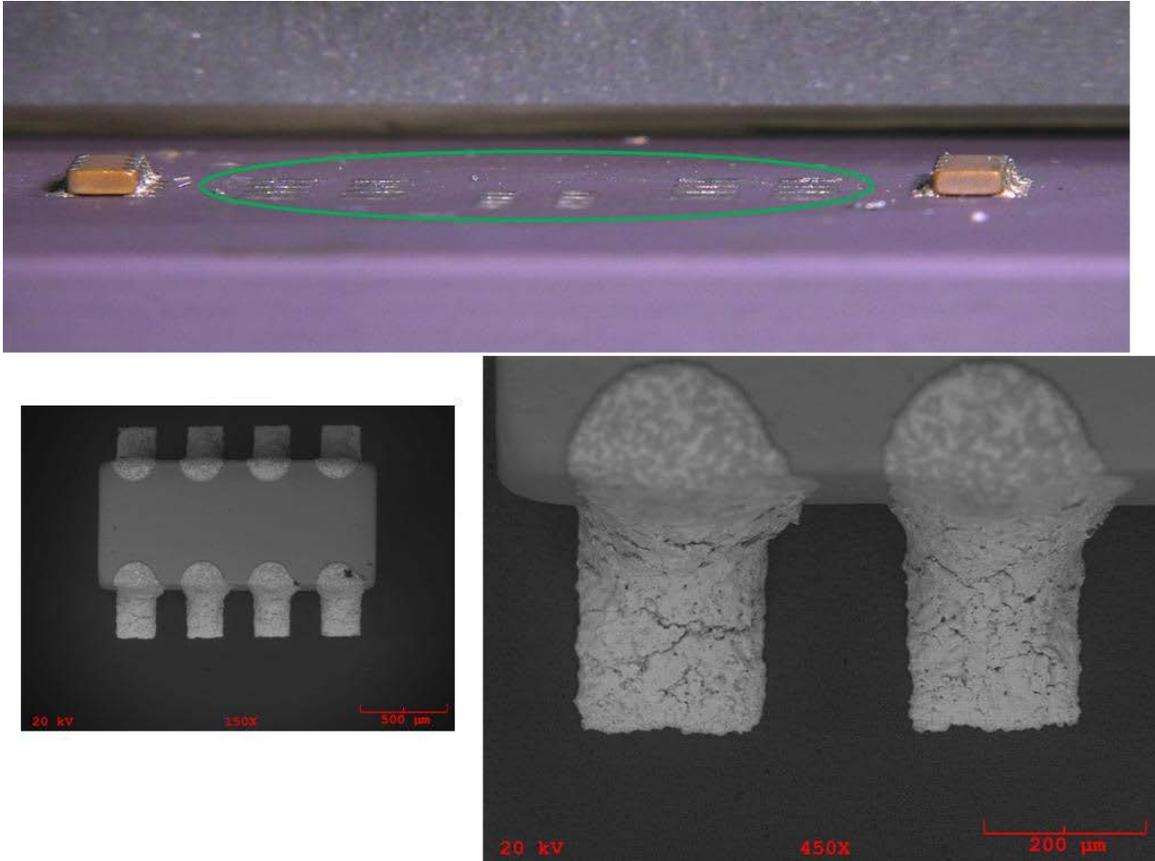
Figure 12. SEM photomicrographs of chip-capacitor solder joint quality after an assembly reflow cycle (RT-218°C) and thermal cycles (-55° to 125°C) and removal locations.

The unassembled CGA1752 package after thermal exposure was also assembled onto PCB along with the other unexposed packages using eutectic tin-lead solder joint. This and other package assemblies were subjected to thermal cycling using two profiles. The chip capacitors with pre-cycling condition were inspected while on the substrate using optical and SEM. Damage condition of a representative chip capacitor after CGA assembly thermal cycling prior to removal and locations of their removal for subsequent evaluation is shown in Figure 12. The history of thermal cycle condition of these chip capacitors is as follows:

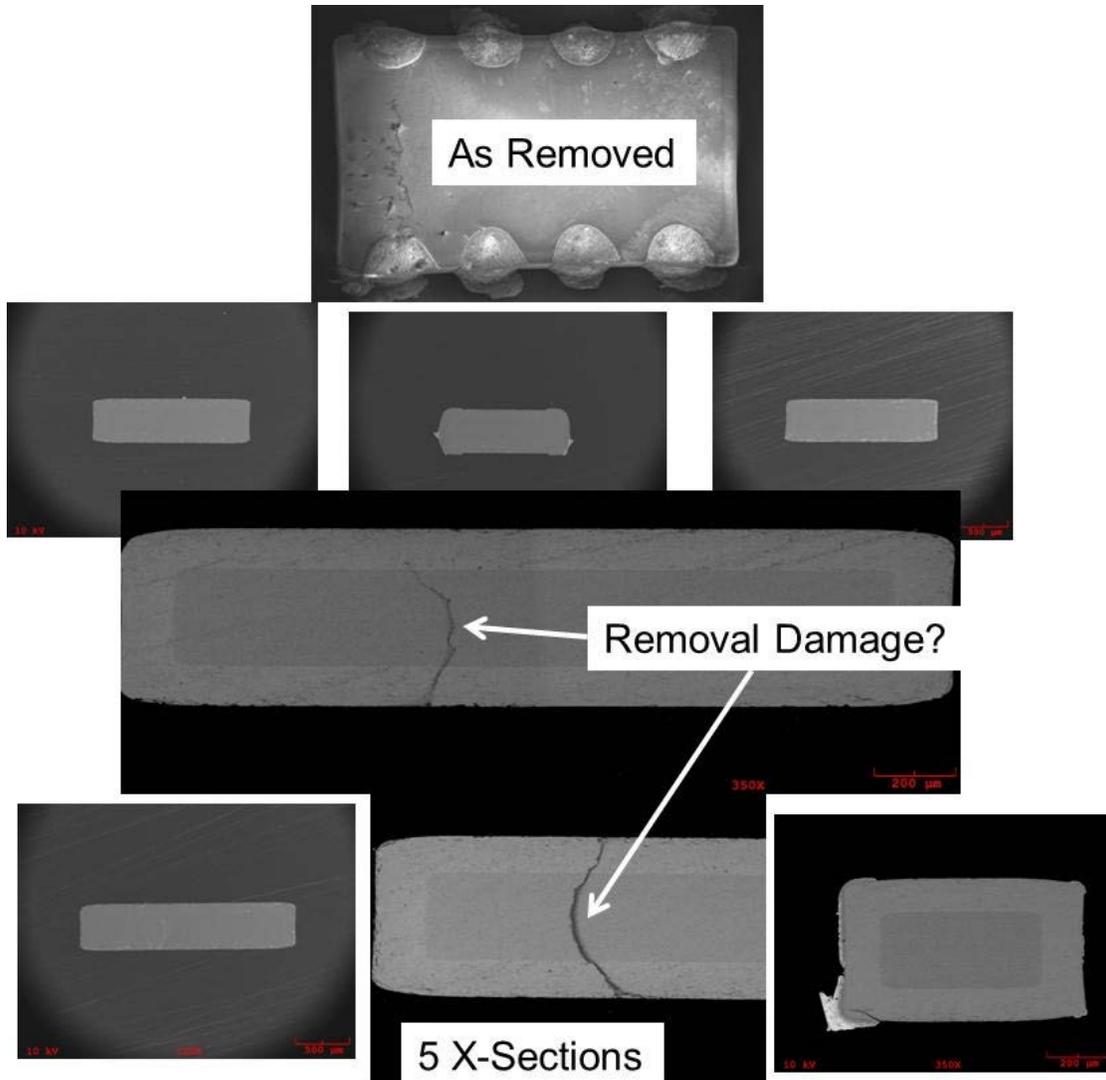
Figure 13. SEM photomicrographs of five chip-capacitor before (top) and after cross-sectioning (five) subjected an assembly reflow cycle (RT-218°C) and thermal cycles (–55° to 125°C).

SEM features of a removed capacitor shows signs of large number of microcracks and gross microstructural features. Cross-sections (see Figure 13) of chip capacitor showed no internal failures even though one showed cracking through section possibly due to methods of removal of chip from substrate by mechanical means. Option of de-soldering of solders for capacitor removal was not considered since it is thought that such thermal shock could cause formation of internal microcracks or failure, which would have been difficult to distinguish from the induced environmental thermal shock or thermal cycle testing.

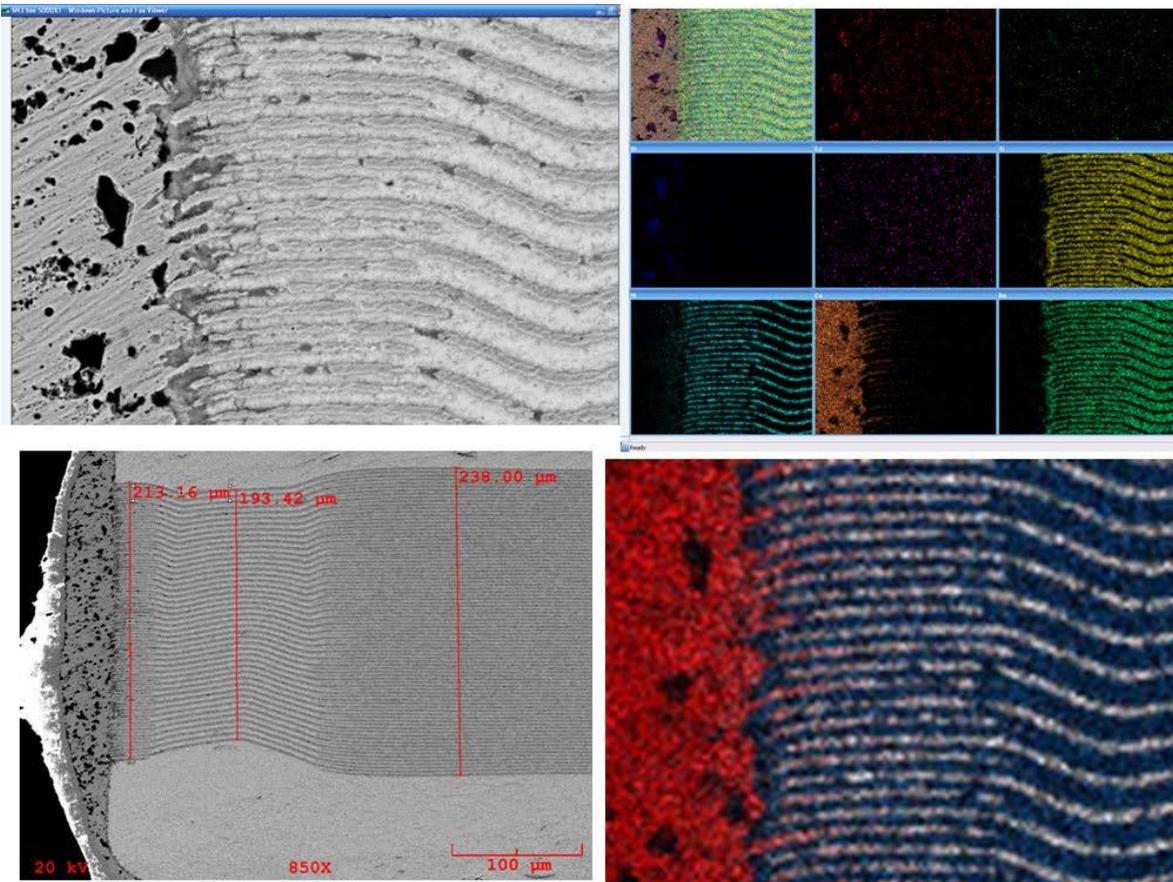
Figure 14. SEM photomicrographs of chip-capacitor showing EDS elemental analysis of layers and end cap as well as dimensions of those layers

SEM EDS elemental analysis and mapping for capacitor’s interlayer chemical distribution are shown in Figure 14. Capacitor was identified as BaTiO₃ dielectric with Ni electrodes. BaTiO₃ capacitor is part of category of capacitors that are known as base metal electrode (BME) which were developed to meet the needs of microelectronic industry for reduction in cost, demand in increasing capacitance, and move towards shrinking in size.

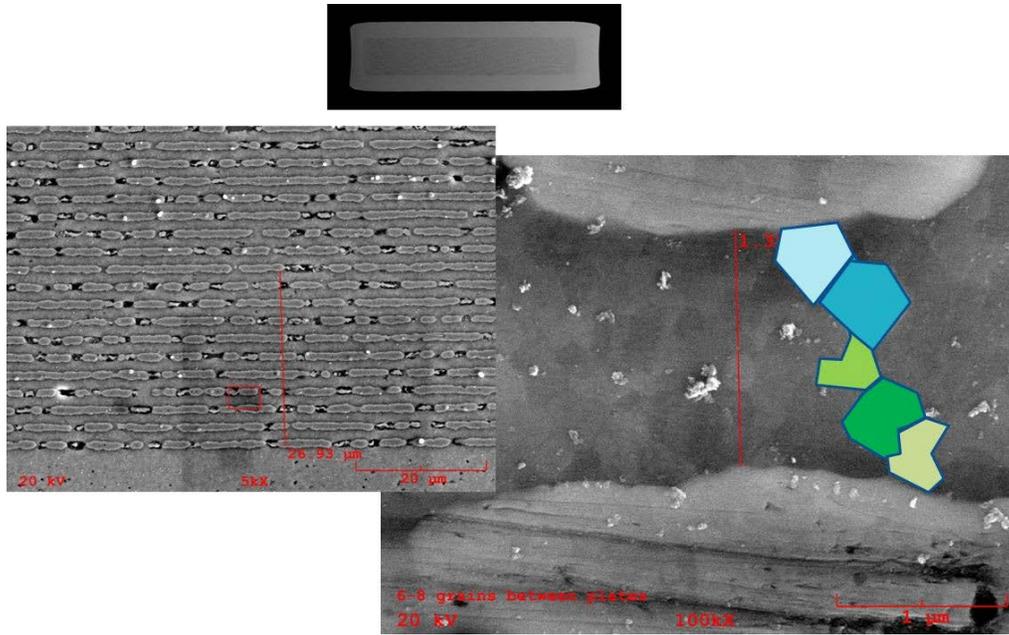
Figure 16. SEM photomicrographs of cross-section of a chip-capacitor showing layers and grain size distribution of BaTiO_3 . Colors are traces of grain boundary to delineate grain sizes.

The metallographic mount of chip capacitors, which had been removed from thermal cycled assemblies of CGA1752, were further polished in order to reveal grain microstructure. It is reported [7] that grain microstructure and size play an important role on capacitor reliability. Figure 16 shows an example of the thermal cycled BME capacitor layering at high magnifications to delineate grain size. To further emphasize grain structure, a number of grains were roughly traced since contrast between grains is low and it may be difficult to distinguish them when viewed in the SEM photomicrographs. Based on the scale given on the bottom of photomicrographs, grain sizes are in tenth of micron in length whereas the layers are in order of micron in thickness.

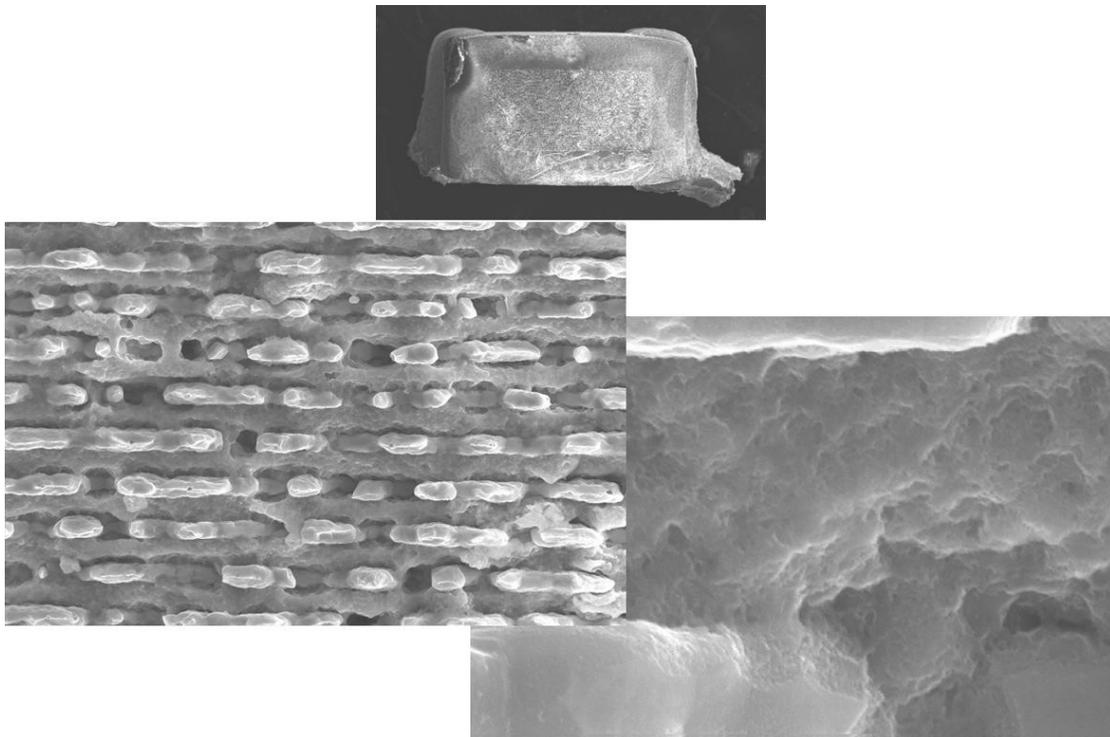
Figure 17. SEM photomicrographs of fracture surface of a chip-capacitor showing layers and indistinguishable grains of BaTiO_3 .

Another approach for revealing microstructure is to fracture capacitor and then perform SEM analysis on the fractured surface. Even though excellent contrast was achievable in the fractured surface (see Figure 17), etching of surface for this sample was not sufficient to reveal the grain microstructures.

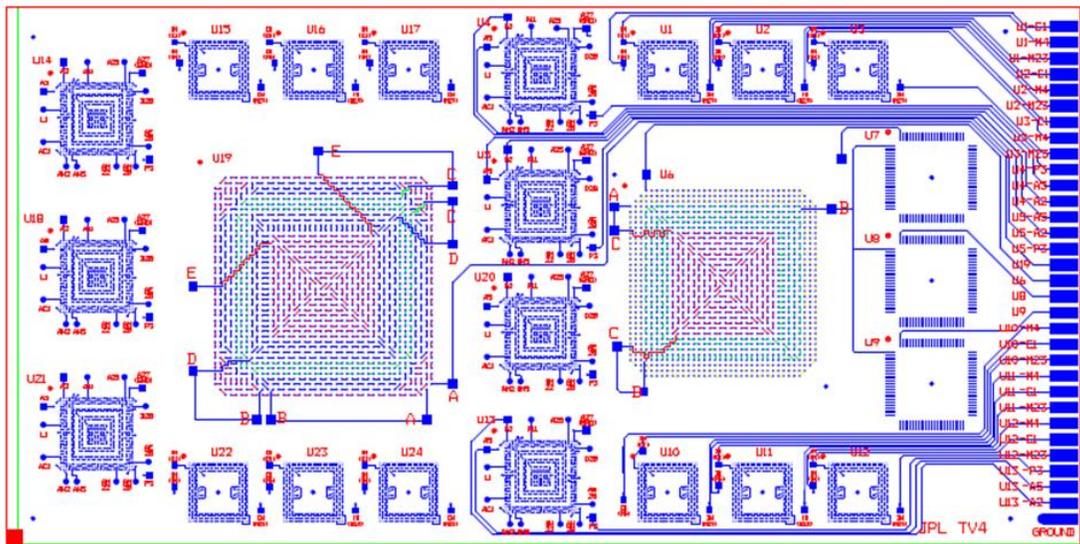
Figure 18. Test vehicle design showing both combined package and board daisy-chain patterns for the two CGA packages. A few other daisy-chain patterns currently not used for evaluation are also apparent in the design.

A complex PCB was designed to accommodate the two CGA packages and also to provide sites for other advanced fine-pitch array and leaded/no-lead packages. Figure 18 shows the board design, with daisy-chain pattern, and how traces are routed to the edge of the board for daisy-chain monitoring.

- The CGA1752, with 1.0-mm pitch and 42.5-mm² body size, designed with enough space for rework evaluation at one side. Numerous daisy chains were designed on board to complement daisy chains on a package, in order to generate complete chains for solder joint failure monitoring. Probe pairs were added near packages to monitor subdivided daisy chains.

- The CGA1272, with 1.0-mm pitch and 37.5-mm² body size, designed with enough space for rework evaluation. Lead parts are designed to determine the influence of rework visually. Numerous daisy chains were designed on board to complement daisy chains on a package, in order to generate complete chains for solder joint failure monitoring. Probe pairs were added near packages to monitor subdivided daisy chains.

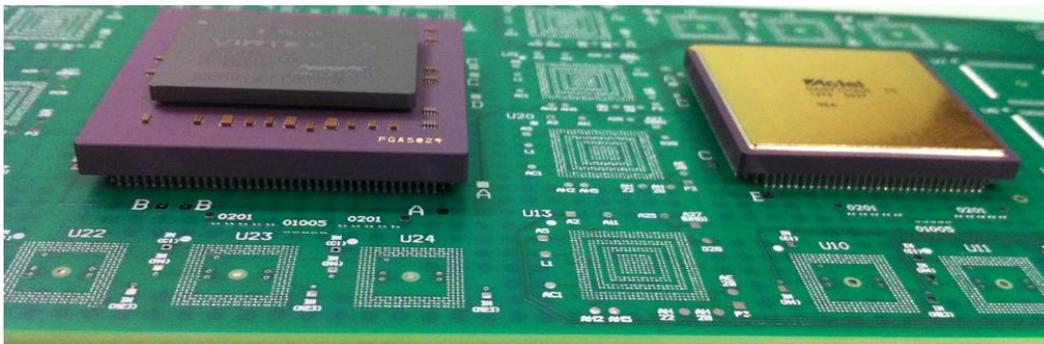
Figure 19. Assembled test vehicle showing the two CGA packages with different sizes and column styles.

These assemblies were first subjected to inspection and daisy-chain continuity checks to determine manufacturing robustness of various package configurations. Figure 19 shows an assembled test vehicle. They will be then exposed to a number of environmental conditions to evaluate their reliability and failure mechanisms. Both the paste print quality evaluation and also inspection after assemblies are discussed below.

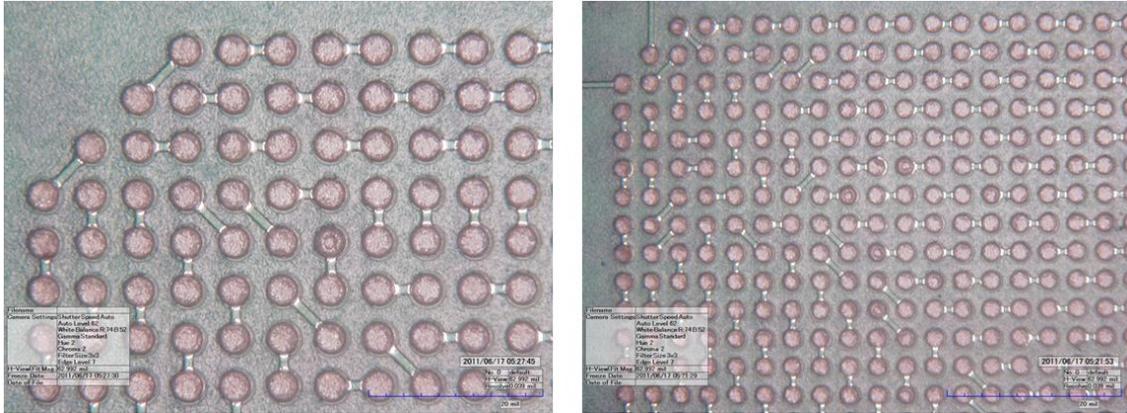
Figure 20. Representative photomicrographs of paste print deposition quality for the CGA1272 I/O (left) and CGA1752 I/O (right).

The rule of thumb for an aperture opening size is to be about four to five times the solder powder diameter. After deposition, each paste print was visually inspected using a microscope for detecting gross defects, such as bridging or insufficient paste deposition. On extremely rare occasions, print quality was improved by either adding a small amount of solder paste when insufficient paste was detected or by removing solder paste from the connecting pads when bridging was discovered. Figures 20 shows representative photomicrographs of paste print and quality for the CGA1272 and CGA1752 I/O packages. Note the daisy chain pattern on board that complements the packages.

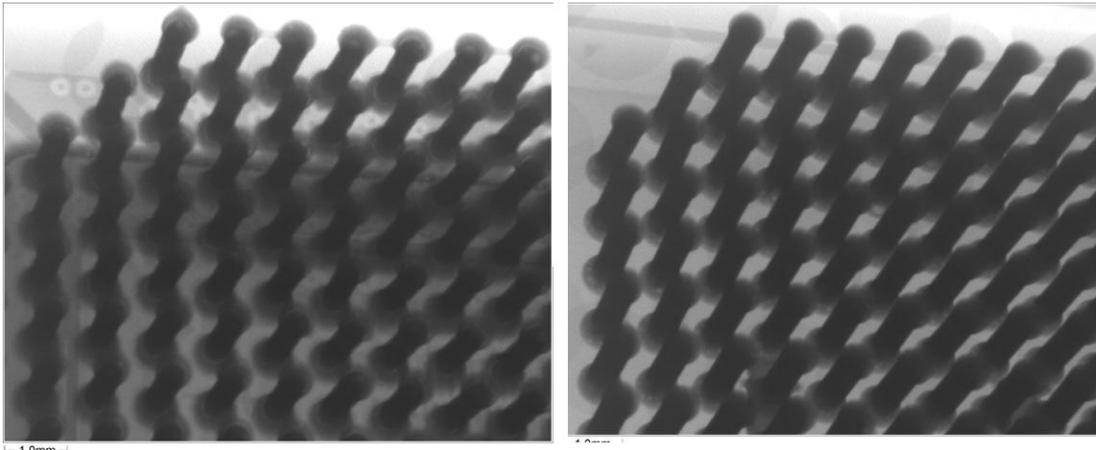
Figure 21. As-assembled X-ray photomicrographs for the CGA1272 I/O (left) and CGA1752 I/O.

X-ray inspection was performed, following visual inspection and the daisy-chain continuity check, to selectively verify package/assembly conditions. The 2D real time X-ray transmission system with oblique angle views was utilized for this inspection. Figure 21 shows representative X-ray photomicrographs for the CGA1752 and CGA1272 packages after assembly.

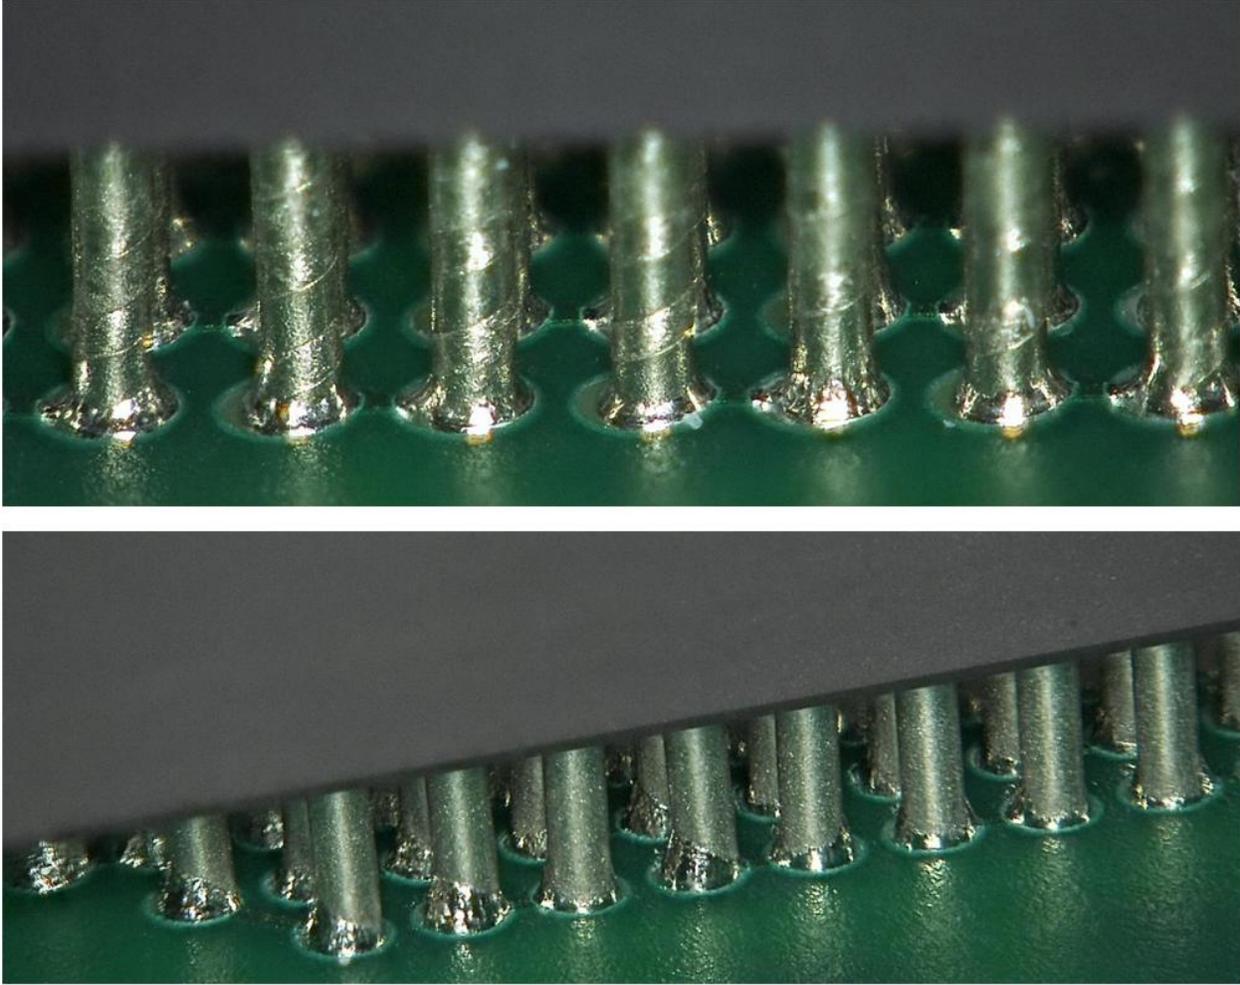
Figure 22. Representative photomicrographs of solder joint quality after assembly for CGA1272 (top) and CGA1752 (bottom).

Visual inspection of peripheral columns was performed for most assemblies, since the board was designed for visual characterization (most of the PCBs were only populated with CGAs). Only outer row, and in some cases, second and third rows could be assessed for solder joint quality. The representative photomicrographs in Figure 21 show the quality of solder joints for CGA1752 and CGA1272 I/O assemblies. Note that solder joint fillet formations are different for the pure column and copper-wrapped solder columns. Solder joints were generally acceptable even though they appear different solder wetting configuration and solder coverage of column periphery.

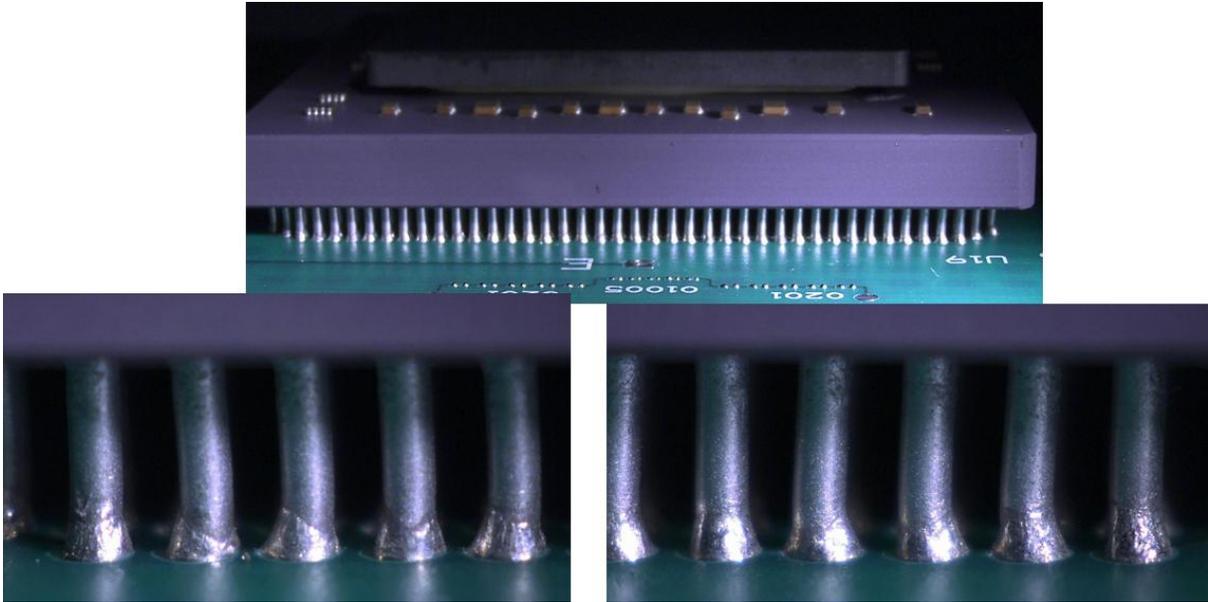
Figure 23. Representative photomicrographs of solder joint quality after 100 thermal cycles ($-55^{\circ}/100^{\circ}\text{C}$) for CGA1752.

Damage progress with thermal cycling was established using an optical microscope. Figures 23–25 present representative photomicrographs of solder joint condition and damage progress due to thermal cycling in the range of –55° to 100°C up to 200 cycles. Damage due to thermal cycling, noticeable from these photomicrographs, can be categorized as follows:

- CGA1752 with high lead solid-solder columns showed partial solder joint coverage of column perimeter with good wetting on the coverage area. Several displaced columns showing a larger corner column shift are apparent. Some column distortions were observed, signs of graininess of solder joints also observable at 200 thermal cycles. In addition, slight apparent column shifts due to shear-induced deformation due to CGA/PCB CTE during thermal cycling.

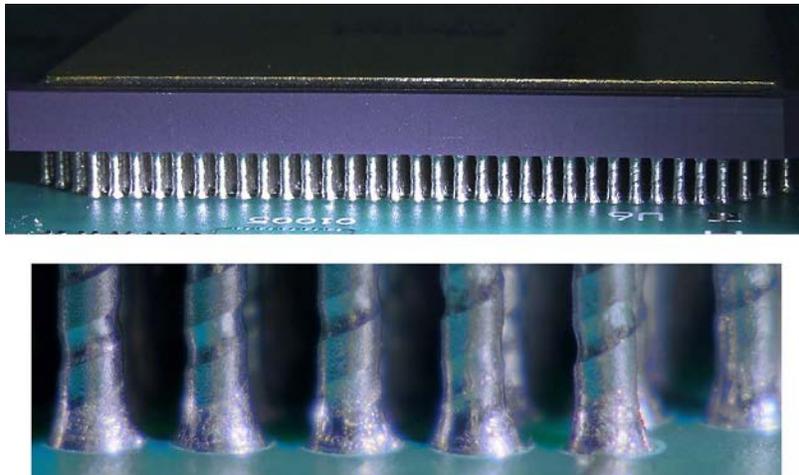
Figure 24. Representative photomicrographs of solder joint quality after 100 thermal cycles ($-55^{\circ}/100^{\circ}\text{C}$) for CGA1272.

- CGA1272 with Cu-spiral column showed good solder joint uniformity and wetting, concave solder surrounding columns. Minimum solder damage was detected due to 100 thermal cycles that slightly increased at 200 cycles; solder/columns showing signs of graininess representing tin-lead solder grain growth due to exposure at 100°C during thermal cycling. Column distortions were minimal, except for graininess of solder exposed between the Cu wrap at 200 thermal cycles. In addition, no apparent column shifts due to shear-induced deformation due to CGA/PCB CTE during thermal cycling.

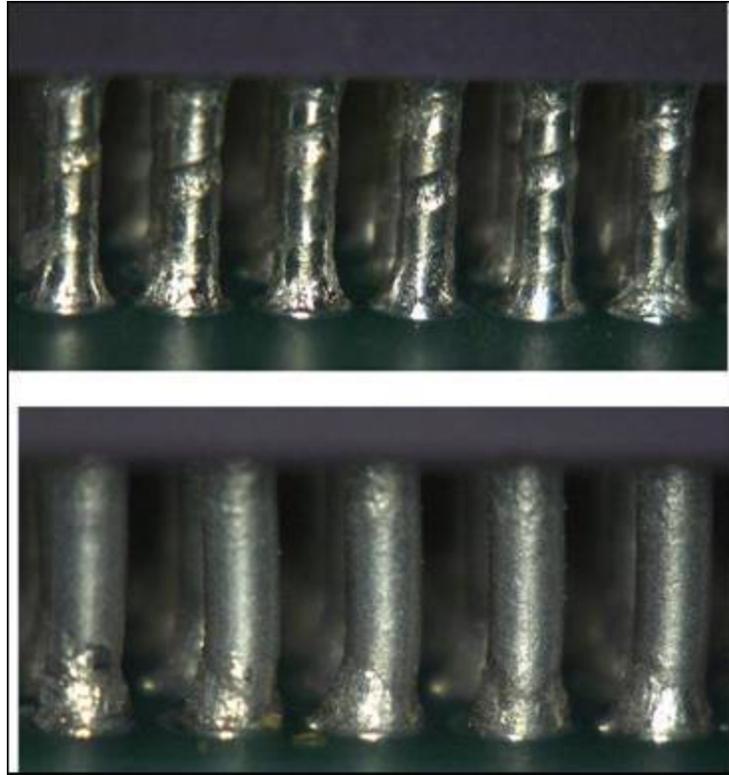
Figure 25. Representative photomicrographs of solder joint quality after 200 thermal cycles ($-55^{\circ}/100^{\circ}\text{C}$) for CGA1272 (top) and CGA1752 (bottom).

In general, less deformation occurred due to thermal cycling to 200 cycles for CGA1272 having lower package size and high column rigidity due to Cu wrap— both factors cause to induce lower thermal stress on solder joint attachment— compared to larger CGA1752 package assembly with no strengthening Cu wrap.

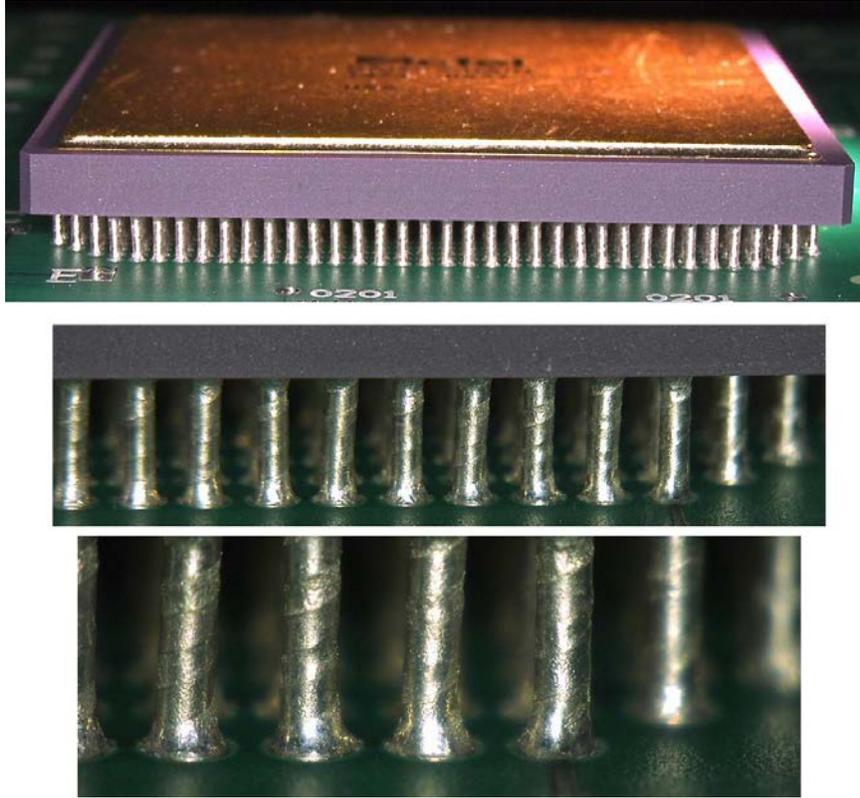
Figure 26. Representative photomicrographs of solder joint quality after 200 thermal cycles ($-55^{\circ}/125^{\circ}\text{C}$) for CGA1272.

Visual inspection was performed to establish damage progress of outer columns of CGAs at thermal cycling intervals by optical microscopy. Figures 26–27 present representative photomicrographs of solder joint condition and damage progress due to thermal cycling in the range of -55° to 125°C at 200 cycles. Damage due to thermal cycling, noticeable from these photomicrographs, can be categorized as follows:

- CGA1272 with Cu spiral column showed good solder joint uniformity and wetting. Some solder damage at 200 cycles showing signs of graininess representing of tin-lead solder grain growth due to exposure at 125°C during thermal cycling. Column distortions were minimal, except for signs of graininess of solder between Cu wrap, at 200 thermal cycles with no apparent column shifts due to thermal cycling.
- CGA1752 with high lead solder column showed partial solder joint coverage of column perimeter and good wetting on the coverage area. Several displaced columns showing a larger corner column shift are apparent. Magnified photomicrographs of corner columns clearly show signs of damage and even microcrack formation. Damage is much more severe when compared to previous thermal cycle condition with 100°C maximum TC.
