Reliability of CGA/LGA/HDI Package Board/Assembly

JPL Publication 12-3 2/13

NASA Electronic Parts and Packaging (NEPP) Program
Office of Safety and Mission Assurance

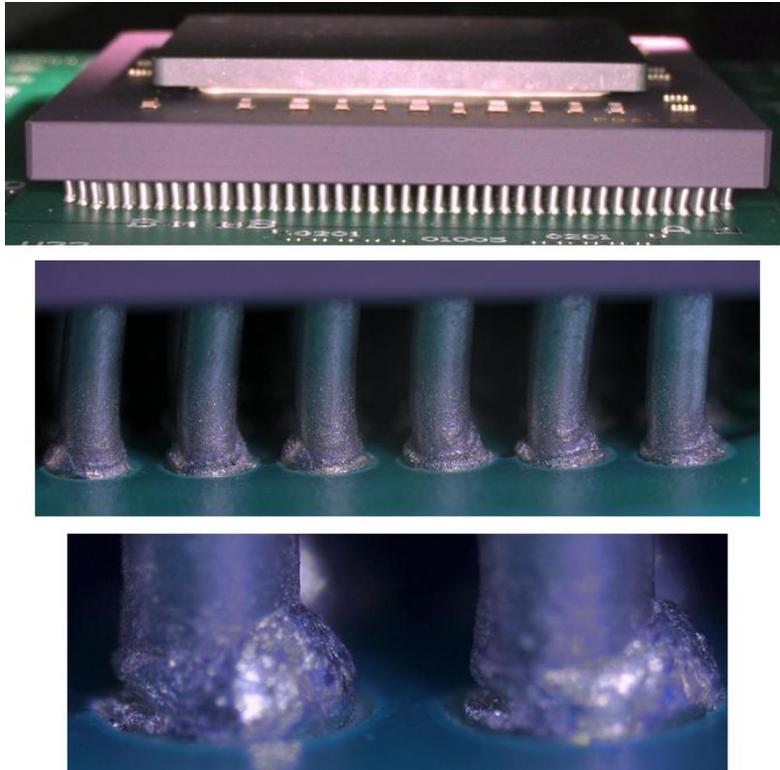
Figure 27. Representative photomicrographs of solder joint quality after 200 thermal cycles ($-55^{\circ}/125^{\circ}\text{C}$) for CGA1752.

Visual inspection was performed to establish damage progress of outer columns of CGAs at thermal cycling intervals by optical microscopy. Figures 26–27 present representative photomicrographs of solder joint condition and damage progress due to thermal cycling in the range of -55° to 125°C at 200 cycles. Damage due to thermal cycling, noticeable from these photomicrographs, can be categorized as follows:

Similarly to thermal cycle condition A, less deformation occurred for CGA1272 with lower package dimension and higher rigidity of columns—both factors induce lower thermal stress on solder joint attachment—compared to larger CGA1752 package and lower rigid pure solder columns. Note also that solder damage and microcracks induced especially for CGA1752 were generally significantly higher than those under A cycling condition.

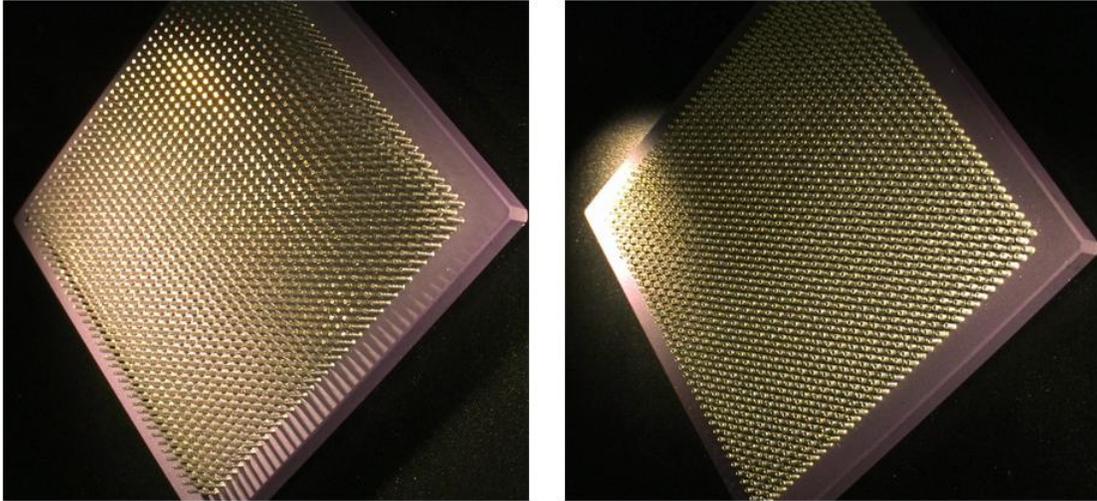
Figure 28. Representative photomicrographs of an LGA package after copper column (left) and micro-spring coil column (right) attachment.

This report covered many aspects of advanced area array packaging and high density printed circuit boards. The purpose of the following aspect of the investigation was to characterize the reliability of LGA1517 packages with 1-mm pitch. LGAs were subject to both copper-wrapped column and microspring coil attachment for subsequent evaluation. Column attachment integrity was evaluated by subjecting a CGA version to isothermal aging and pull tested before and at intervals during environmental aging. Figure 22 shows photomicrographs of the LGA package after it was transformed to CGA.

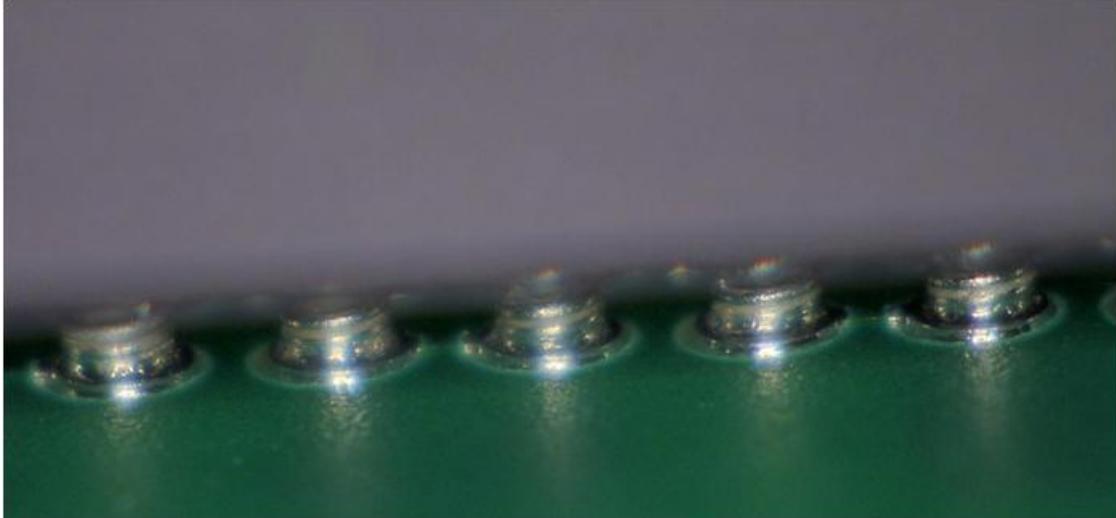
Figure 29. Representative photomicrographs of solder joint quality after assembly for microspring coil column CGA1571.

LGAs with copper-spiral solder columns and those with microspring coils were assembled onto two different PCBs with both standard and smaller pad diameters; this accommodated the two column/spring diameters. During the processing of LGAs with microspring coils, a CGA1272 was also assembled onto the board as a baseline for process and reliability evaluation. Visual inspection of peripheral columns was performed for these assemblies since the board was designed for visual characterization, especially since most of the PCBs were only populated with CGAs. Only outer rows, and in some cases, second and third rows, could be assessed for solder joint quality. Verification by daisy-chain resistance measurement was not possible since LGAs had no daisy-chain package design. The photomicrograph in Figure 29 shows the quality of solder joints for microspring coil of a column CGA assembly. Note that solder joint fillet formations are different since there are no solid solder columns; however, good quality solder fillet formation is apparent. Figure 30 shows solder joint quality of a copper-wrapped column assembly.

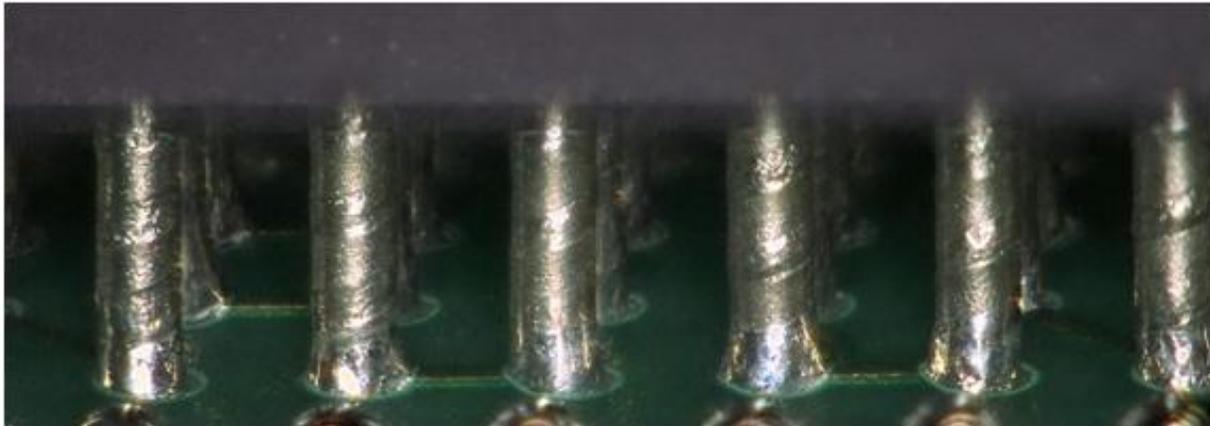
Figure 30. Representative photomicrographs of solder joint quality after assembly for CGA1571 with copper-wrapped solder columns.

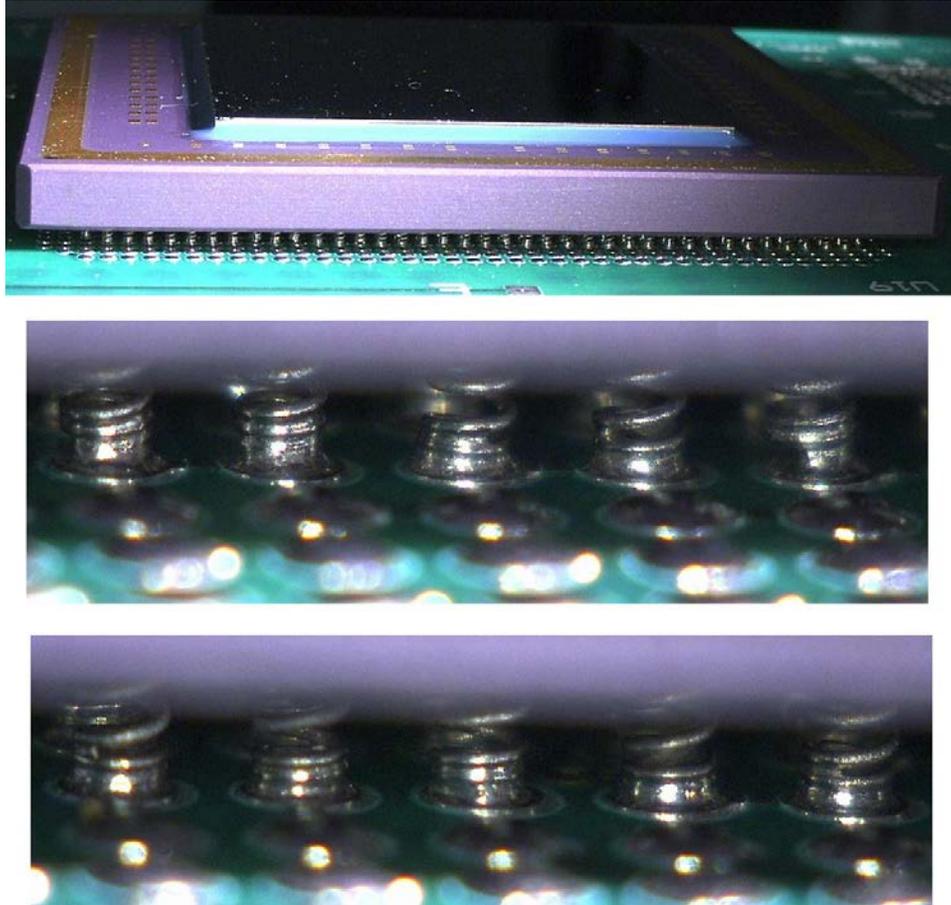
Figure 31. Representative photomicrographs of solder joint quality of microspring column attachment after 200 thermal cycles ($-55^{\circ}/100^{\circ}\text{C}$) for CGA1517.

In addition to daisy-chain monitoring for CGA1272, visual inspection was also performed by optical microscopy to establish damage progress of outer columns of all CGA assemblies at thermal cycle intervals. Figure 31 presents representative photomicrographs of solder joint condition of microspring columns and damage due to thermal cycling in the range of -55°C to 100°C at 200 cycles. Shiny appearance of solder joint reflection light from the microspring column attachment clearly indicates extremely minor damage induction due to 200 thermal cycling.

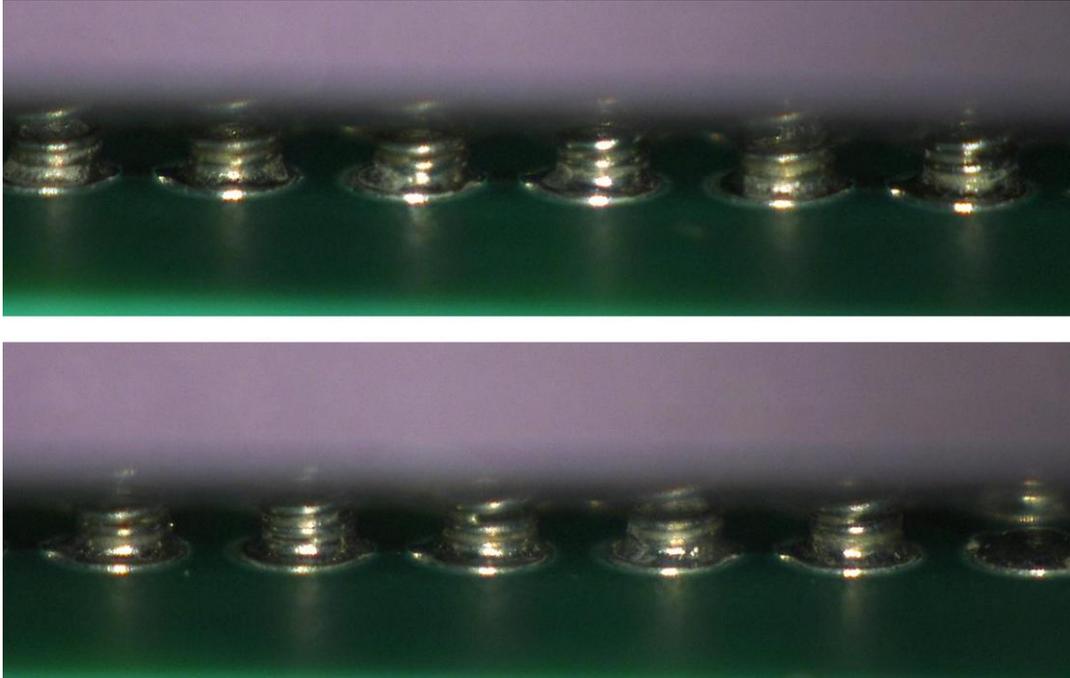
Figure 32. Representative photomicrographs of solder joint quality of microspring column attachment after 200 thermal cycles ($-55^{\circ}/125^{\circ}\text{C}$) for CGA1517.

In addition to daisy-chain monitoring for CGA1272, visual inspection was also performed to establish damage progress of outer columns of all CGA assemblies at thermal cycle intervals by optical microscopy. Figure 32 presents representative photomicrographs of solder joint condition of microspring columns and damage due to thermal cycling in the range of -55°C to 125°C at 200 cycles. Slight darker appearance of solder joints at the PCB side of microspring column attachments indicates minimum sign of damage due to 200 thermal cycling.

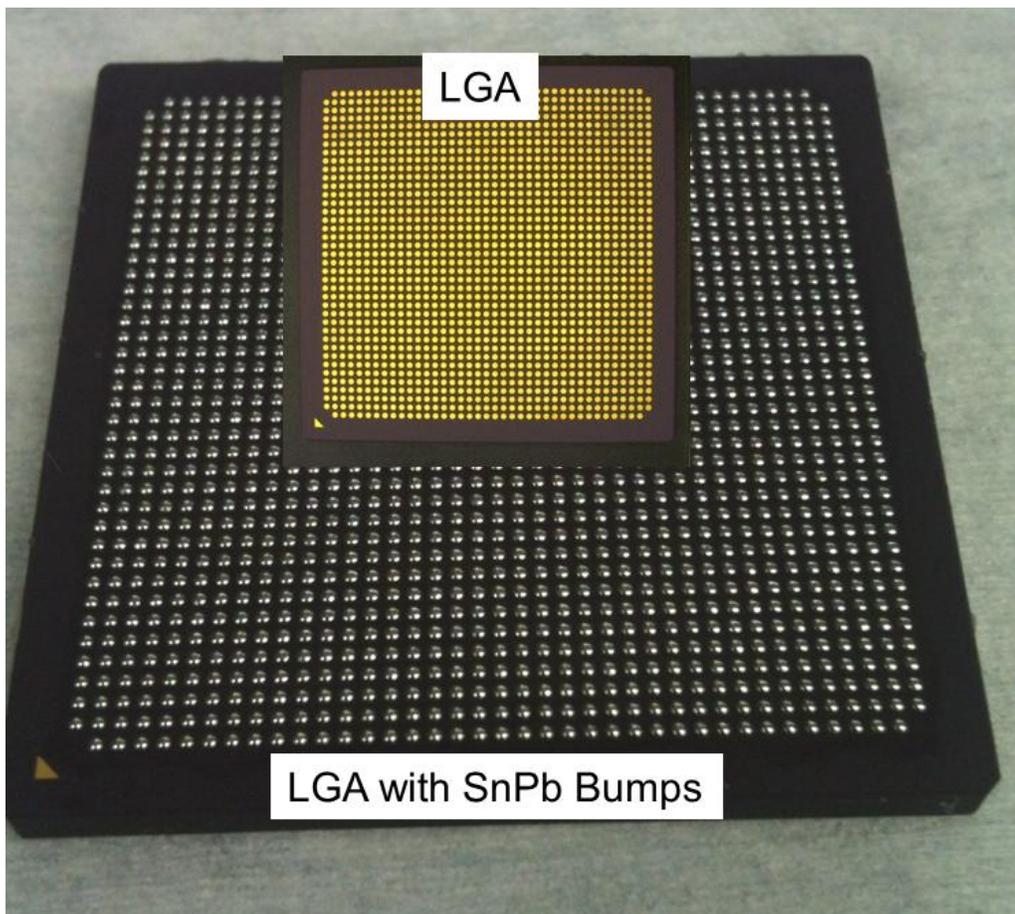
Figure 33. Ceramic land grid array (LGA) package as received (top) and with solder bumps generated by SnPb paste print and reflow (bottom).

Assembly procedure currently recommended for smaller size and plastic version of the LGA package using only solder paste for assembly is considered to cause significant solder bridges. To avoid bridging, the LGA1517 package was first subjected to tin-lead solder paste printing in order to increase solder height as well as to provide some control on standoff during subsequent assembly onto PCB. Solder paste was printed onto package and then reflowed to achieve solder bumps. This process was successful and generated uniform solder bumps with no bridging (see Figure 33).

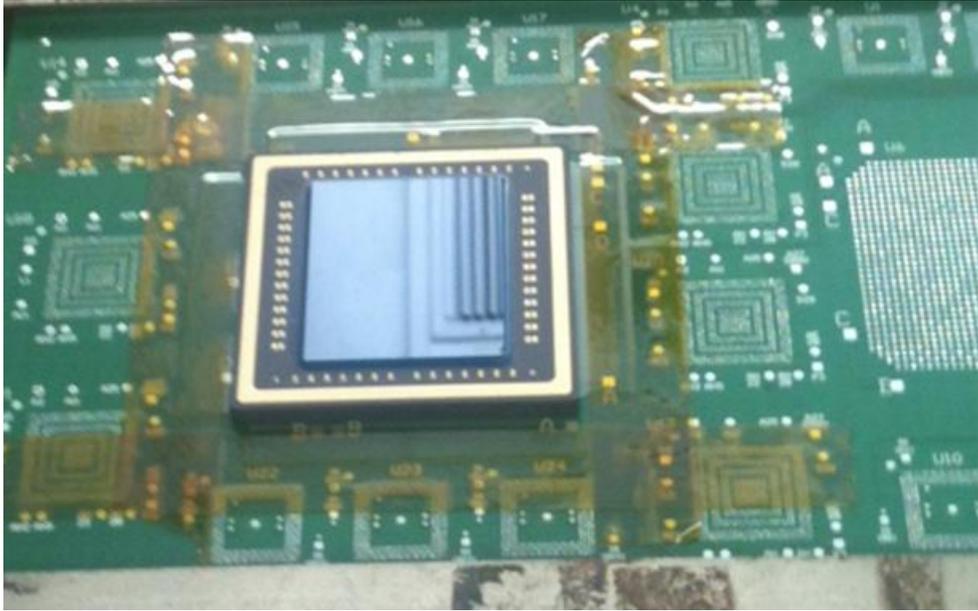
Figure 34. Ceramic land grid array (LGA) package with SnPb solder bumps assembled onto PCB.

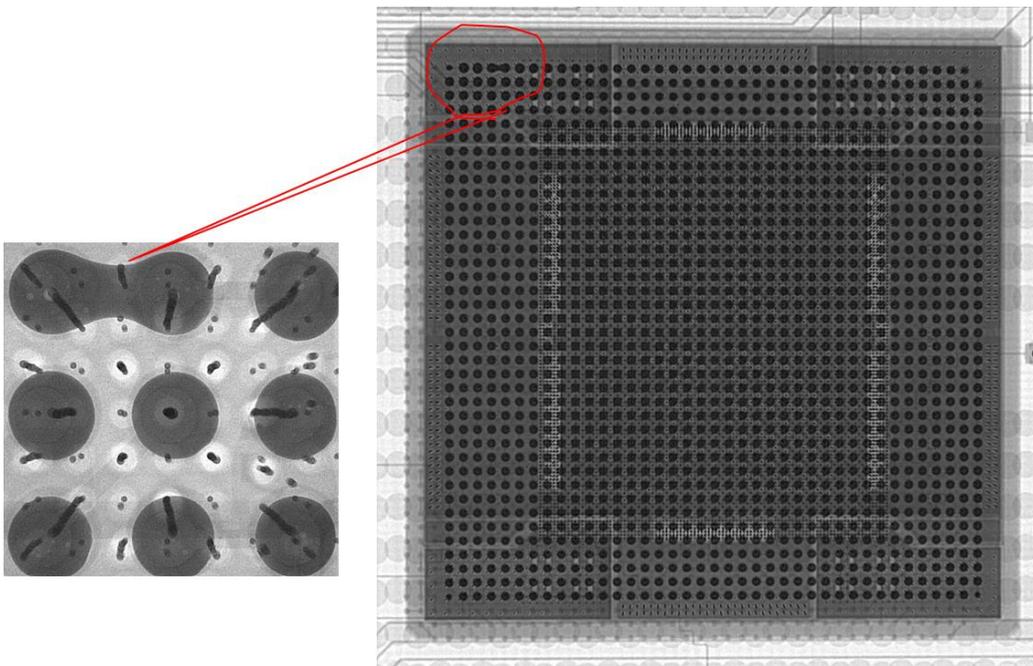
Figure 35. X-ray photomicrographs of assembled ceramic land grid array (LGA) package showing quality of assembly and one solder short.

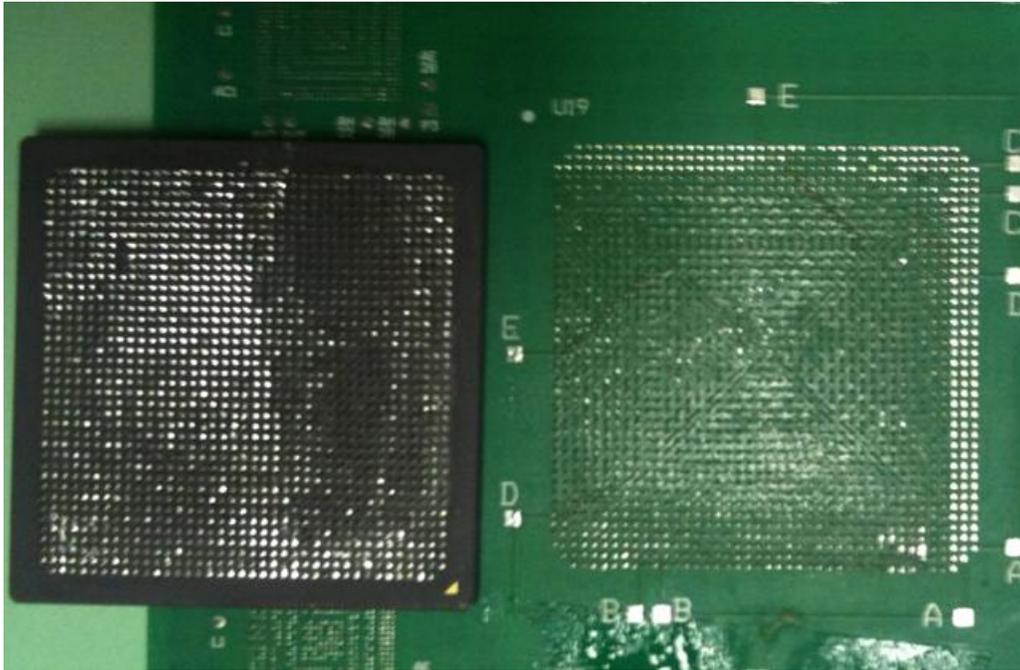
Figure 36. Rework of ceramic land grid array (LGA) package assembly show both package and PCB conditions.
